**The Northland Floods
28-29 March 2007**

Hydrologic Hazards Hindinvestigation

**NIWA Client Report: CHC2007-049
April 2007**

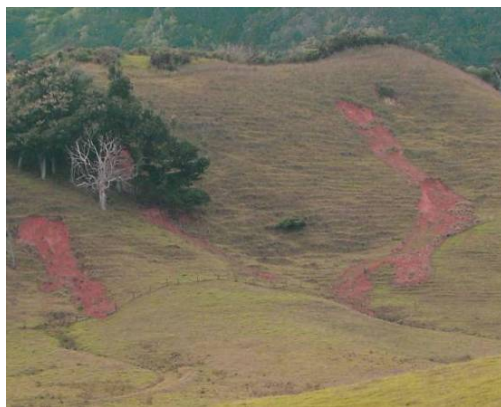
Figure 2: New Zealand is on the move.

Serious damage in the far north was caused primarily by unstable hill slopes (Figs 2 and 4) and inundation (Fig. 3). Many of the recent hill slope failures were re-initiated old slips. Houses are being built “on the edge” of steep slopes because of the views (Fig. 4).

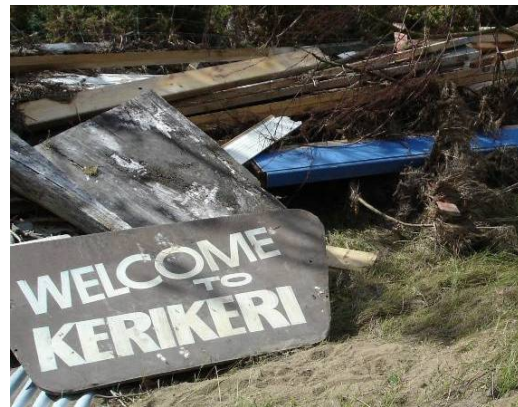
Figure 3: Inundation debris

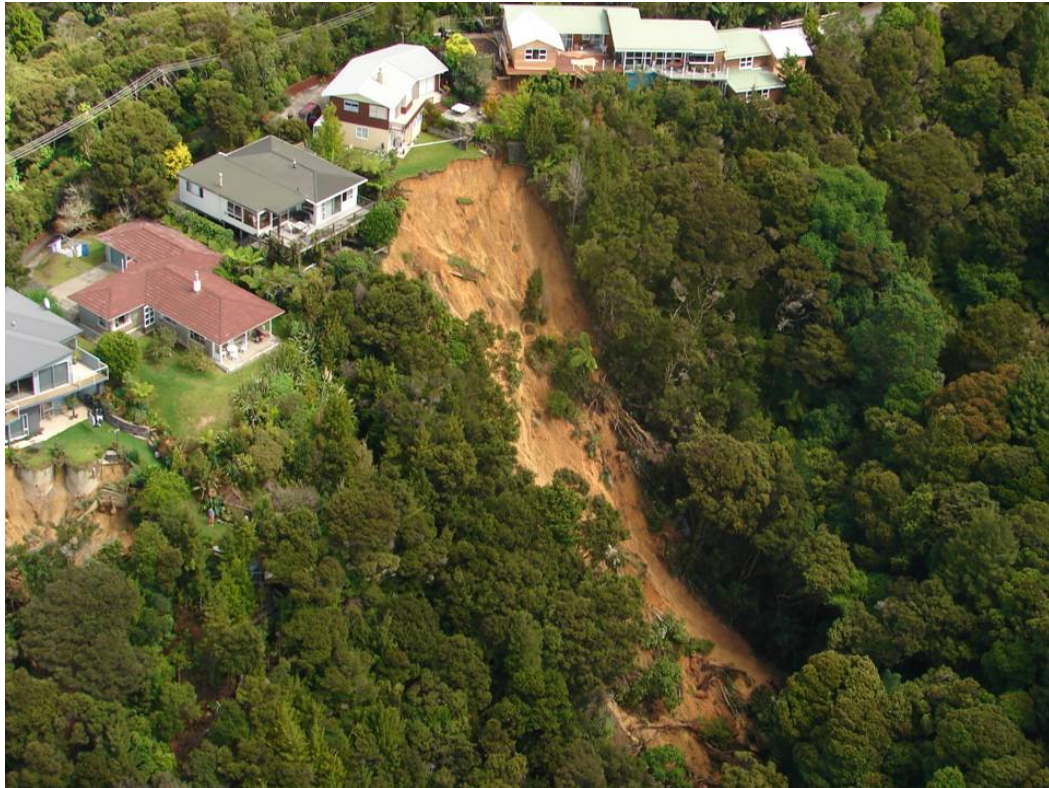
Figure 4: Slope failure at Opuia on 29 March, 2007 (FNDC Photo).

Figure 4 shows a disastrous situation on land that was subdivided in the 1970s. At that time, the Bay of Islands County Council, acting on the advice of the Northland Catchment Commission, turned down the application for a subdivision on the grounds that the land was unsuitable for such an intensity of development because of instability. The Council's decision was overturned by the Town and Country Planning Tribunal (the forerunner of the Environment Court) but the County Council refused to grant building consents for three sections with slopes greater than 47 degrees. The sub-divider sued the Council and was paid compensation for those three sections.

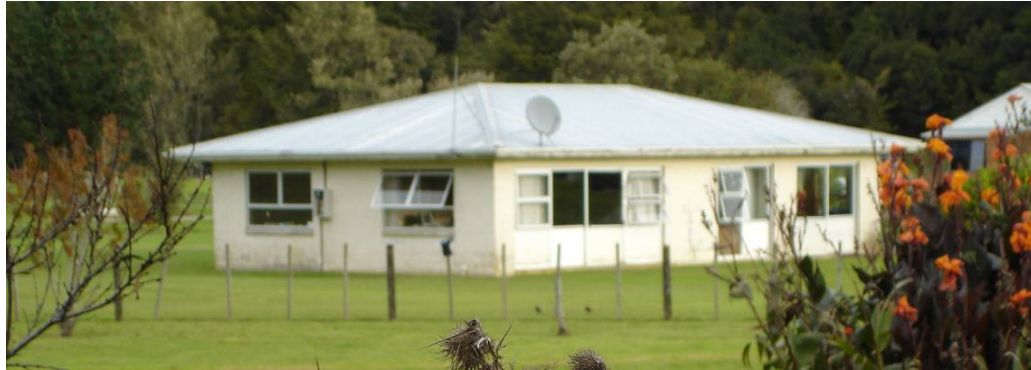
Several households in the Matangirau area (Matangirau School Road) have been displaced because of flooding from the Touwai Stream (Fig. 5). There is a flood avoidance and mitigation plan for this area but it does not appear to have been adopted by the local community.

Figure 5: Flood prone house on the Touwai Stream floodplain, Matangirau.

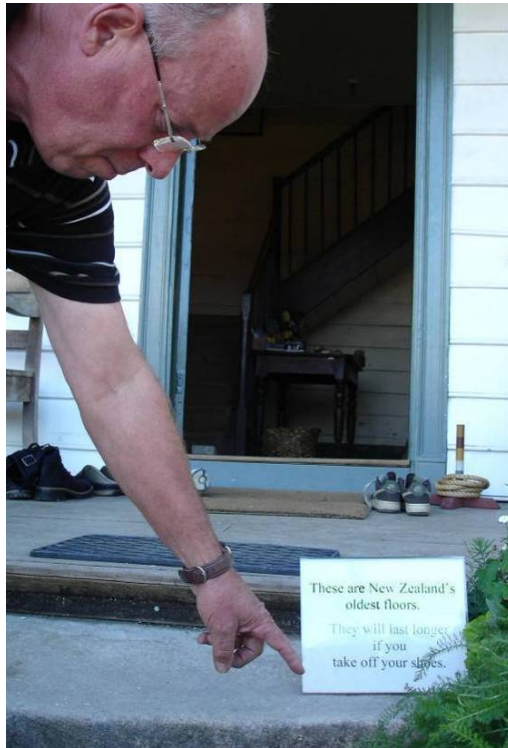
Figure 7: Flood level at Kemp House.

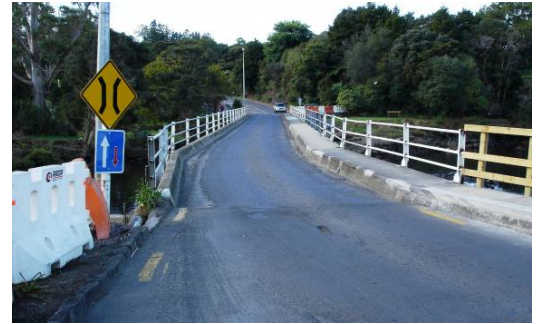
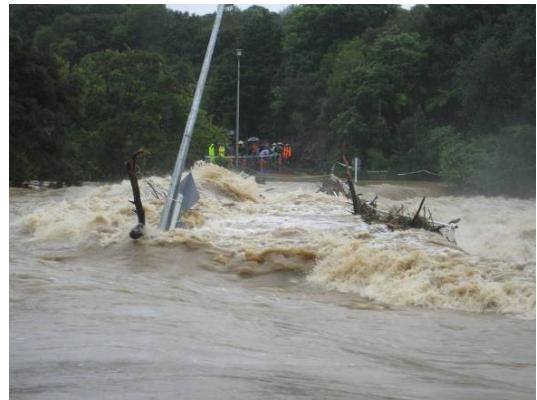
Prediction of accurate levels is difficult because the Kerikeri Basin bridge (Fig. 8, top) acts as a flood constriction (Fig. 8, bottom) except at high tide levels. Debris collect on the bridge (Fig. 9) and restrict its capacity to an unpredictable degree. Removal or raising of this bridge would help safeguard Kemp House and make flood levels more predictable. Flood detention basins could help reduce the flood peak levels.

Figure 8: Kerikeri Basin bridge.

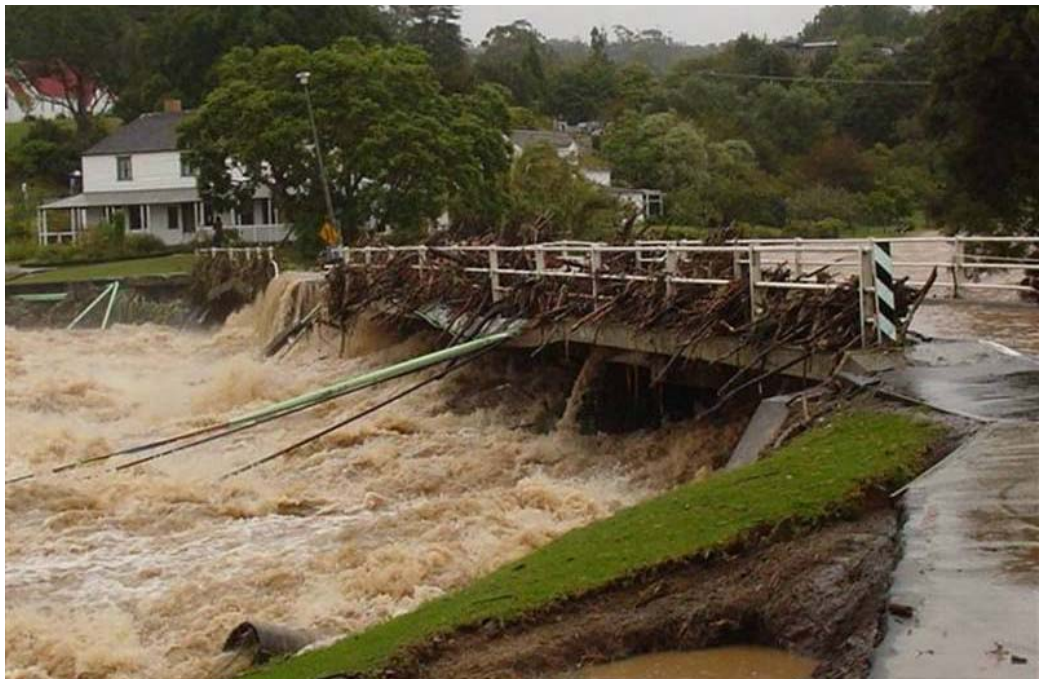
Figure 9: Flood debris on the Kerikeri Basin bridge, Kemp House in background. Photo: FNDC.

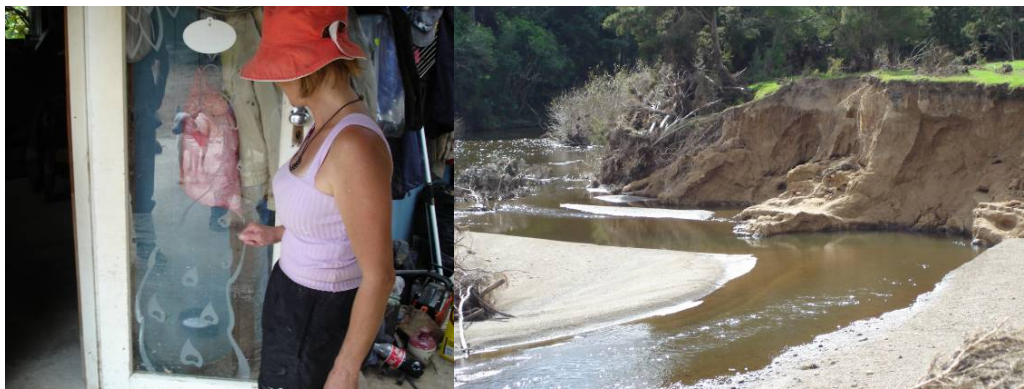
South of Kerikeri the Waitangi River reached the highest water level measured in 28 years of record. It inundated the Lily Pond Farm Park at Puketona and the Haruru Falls Resort. The residents were unaware of the impending flooding. They had heard a “heavy rain warning” but “you get these all the time”. The owners of Lily Pond Farm Park decided to evacuate when the water level reached the top of the fence outside their house. Carrying valuables they waded through flowing flood water waist deep. If the flood had occurred during the night they would have probably drowned as they evacuated. The eventual water level reached sink bench level in the house (Fig. 10).

Figure 10: A resident of Lily Pond Farm Park indicates flood level on the house.

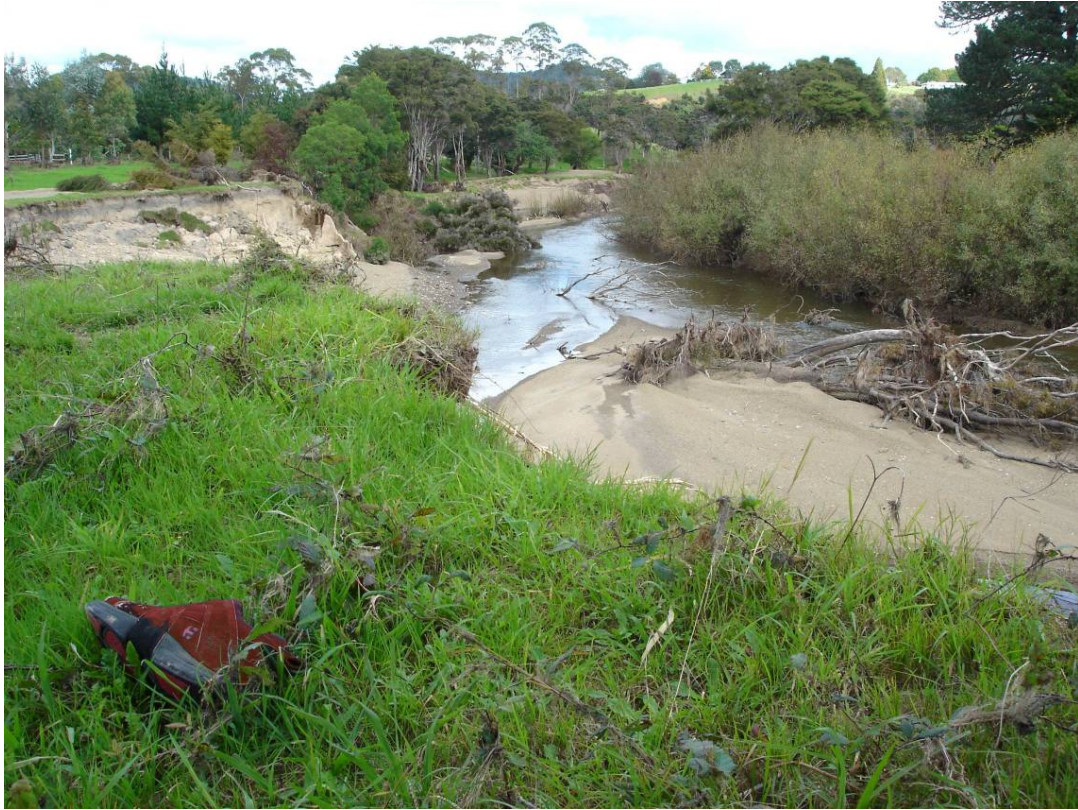
The high flood levels were contributed to by willow growth in the Waitangi River (Fig. 12) which restricted flow and aggravated bank erosion (Fig. 11).

Figure 12: Willow growth in the Waitangi River.

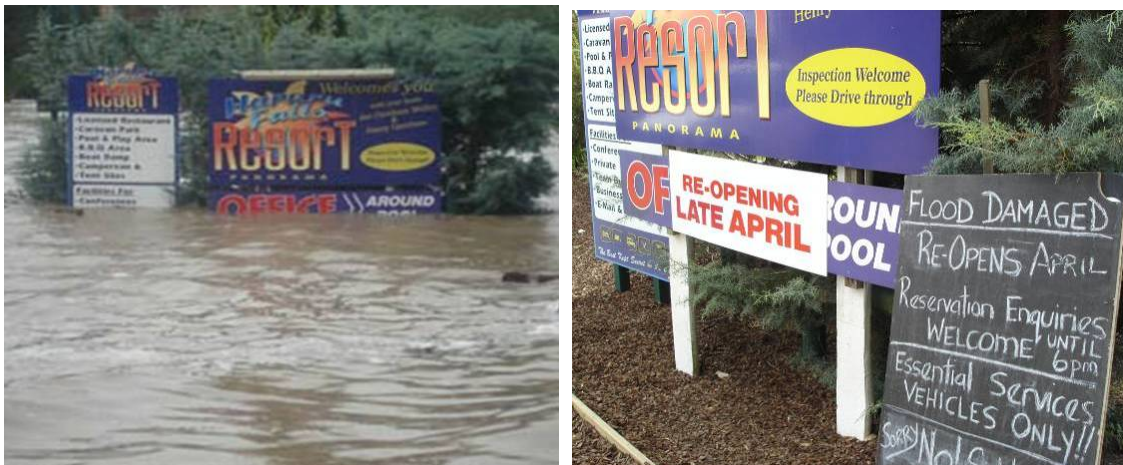
The area below Haruru Falls has had severe flooding in the past (1930s and 1950s) and minor flooding in 1981. In the March 2007 floods the Haruru Falls Resort (Fig. 13) suffered severe damages on two fronts. It was inundated by the river on its lower side (Fig. 14) and partially demolished by landslips on its uphill side (Figs. 15, 16). Some protection to this facility could be offered by retaining walls, flood walls and a flood warning system.

Figure 13: Haruru Falls Resort sign during and following the flood.

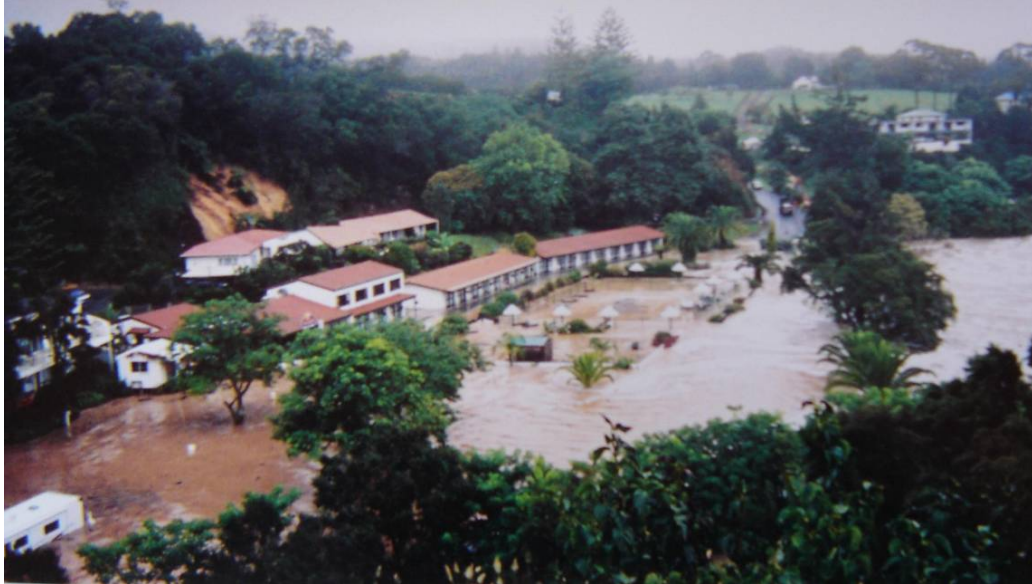
Figure 14: Haruru Falls Resort on 29 March, 2007.

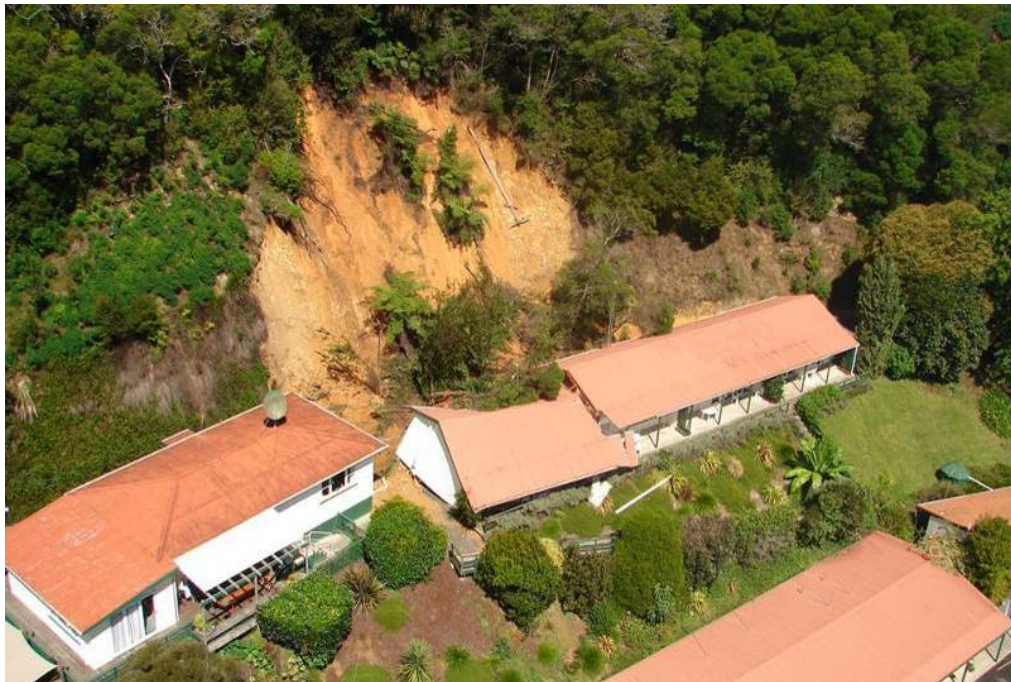
Figure 15: Landslide damage to the back of Haruru Falls Resort. (Photo FNDC)

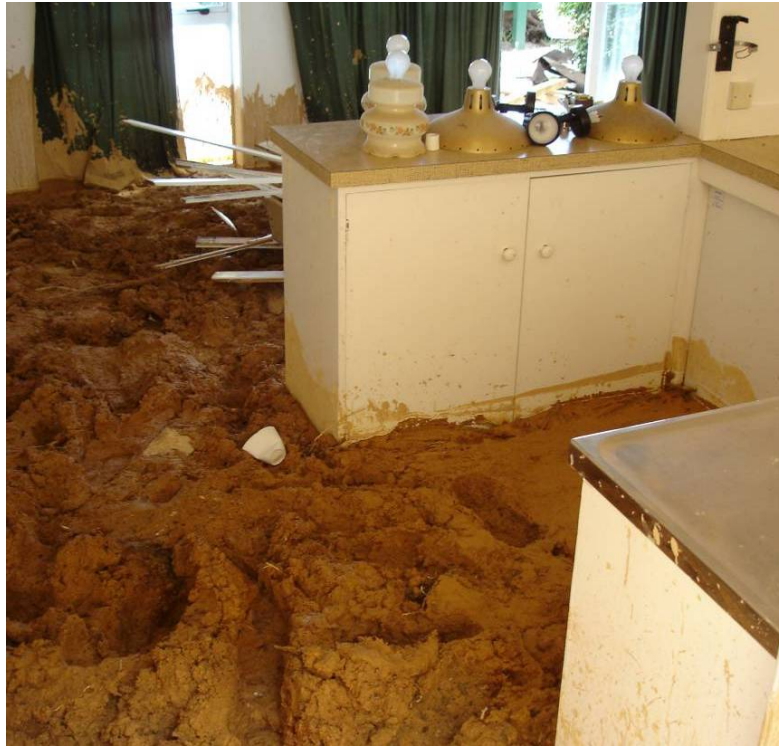
Figure 16: Mud on the carpets at Haruru Falls Resort.

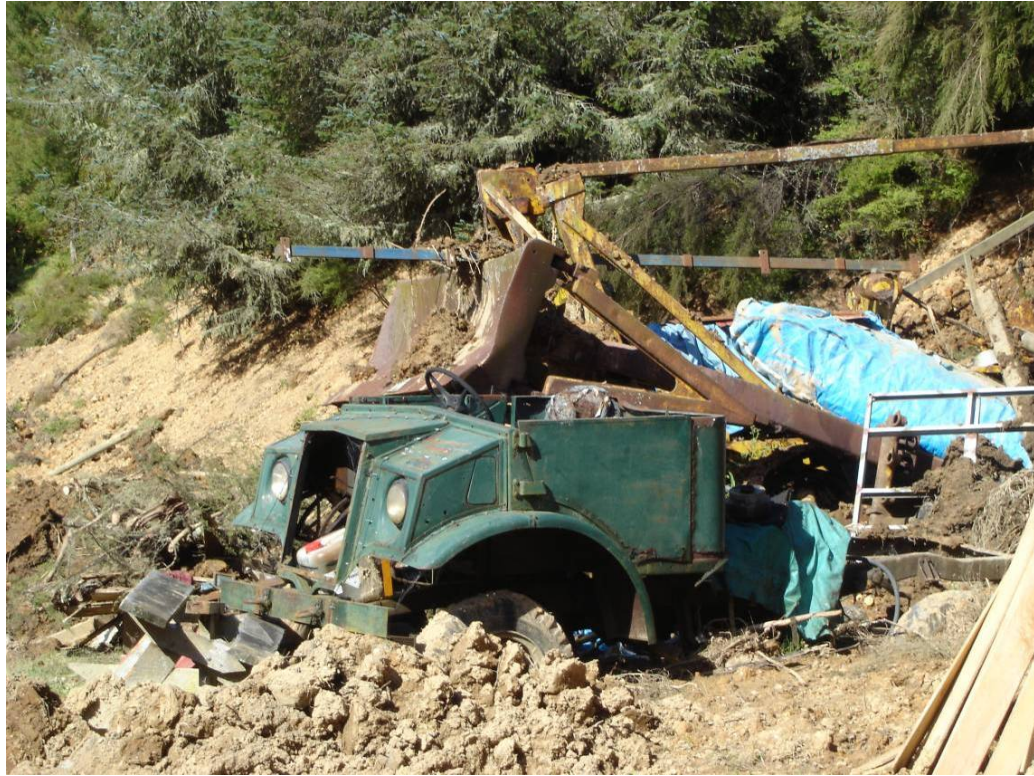
Further south, at Taumarere, the Bike Museum was partially buried by landslides on 29 March (Fig. 17), and a house is in danger of being engulfed during the next deluge. At this site the Taumarere Bike Museum curator, Richard Crowden, measured 100 mm rain in one hour (at about 2pm on 29 March). Such high rainfall intensities were not foreseen by Met.

Figure 17: Landslides engulfed the Taumarere Bike Museum

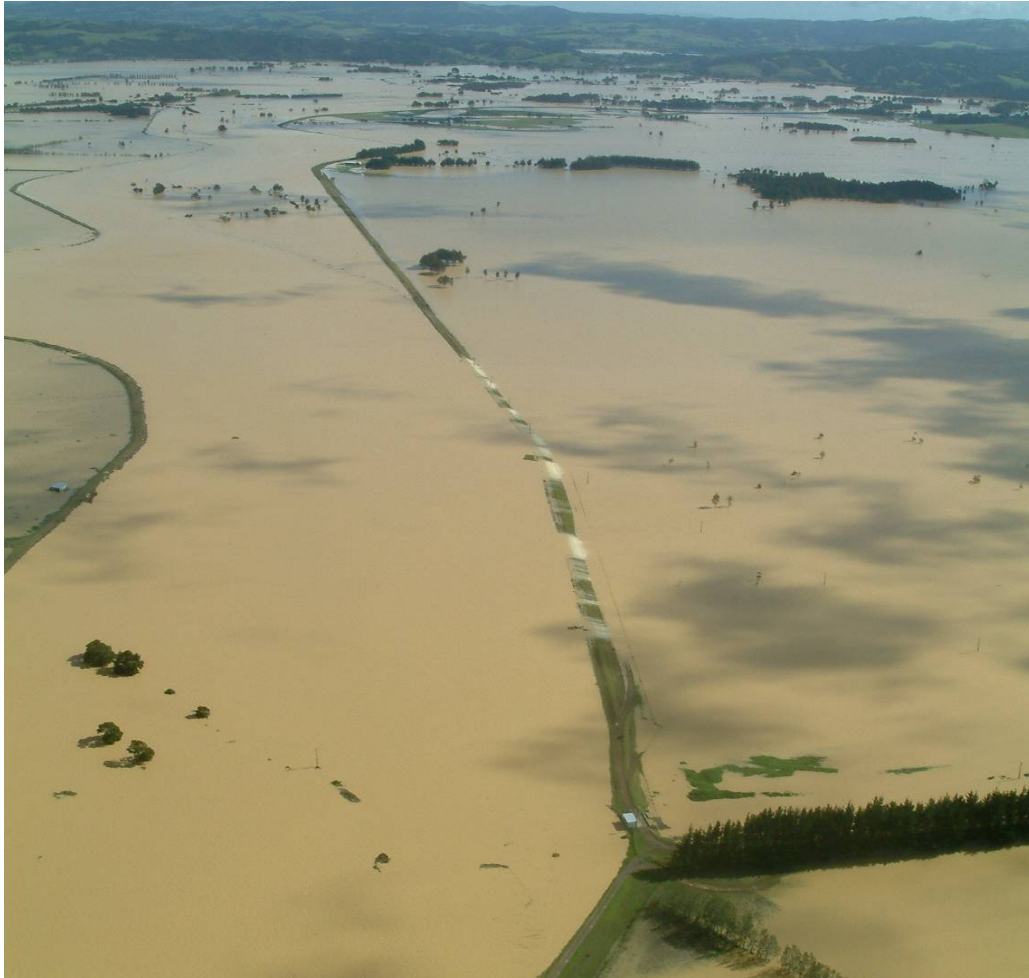
March event the river rose $3\frac{1}{2}$ m in $2\frac{1}{2}$ hours. This surprisingly rapid “flood wave” overflowed upstream “pockets” and 5000 ha of farmland was inundated (Fig. 18).

Figure 18: Wairua River spilling into the Hikurangi Swamp flood pockets Photo: WDC (J Blackburn)

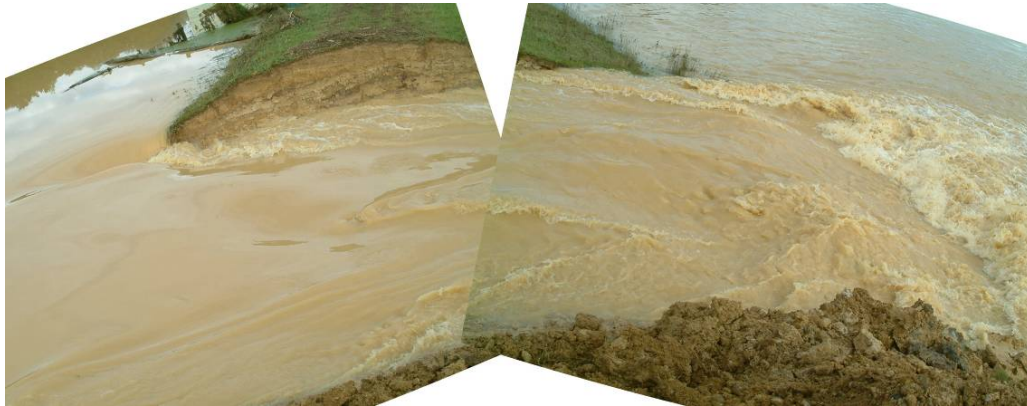
Downstream pockets have the highest pumping capacity but, because of the steepness of the flood wave and the flat grade of the river, these received the least water. Some accounts claim that farmers have raised the river overflow sill levels by several centimetres to offer their land greater protection. Floodwaters from the Wairua River were augmented by runoff from local hills. As a result, an estimated 80,000,000 m³ of water was detained in the scheme ponding area. The pumps could not cope with this volume of ponded water and on Sunday 1 April, stop banks were deliberately cut to drain three of the pockets. A digger made 8 metre wide cuts (Fig. 19) with the base of the cut at river level to reduced scour. The pockets took 8-16 days to drain and large areas of pasture were destroyed by the long-term submersion (Fig. 20).

Figure 19: Hikurangi pockets draining to the Wairua River after the bund was cut.

Future damages could be reduced for such events by giving more flood warning, by distributing the floodwaters more evenly between the pockets, by constructing gated culverts to quickly drain flood waters back to the river after a flood, and by not permitting dwellings or other non-robust infrastructure to be constructed at vulnerable locations within the ponding areas.

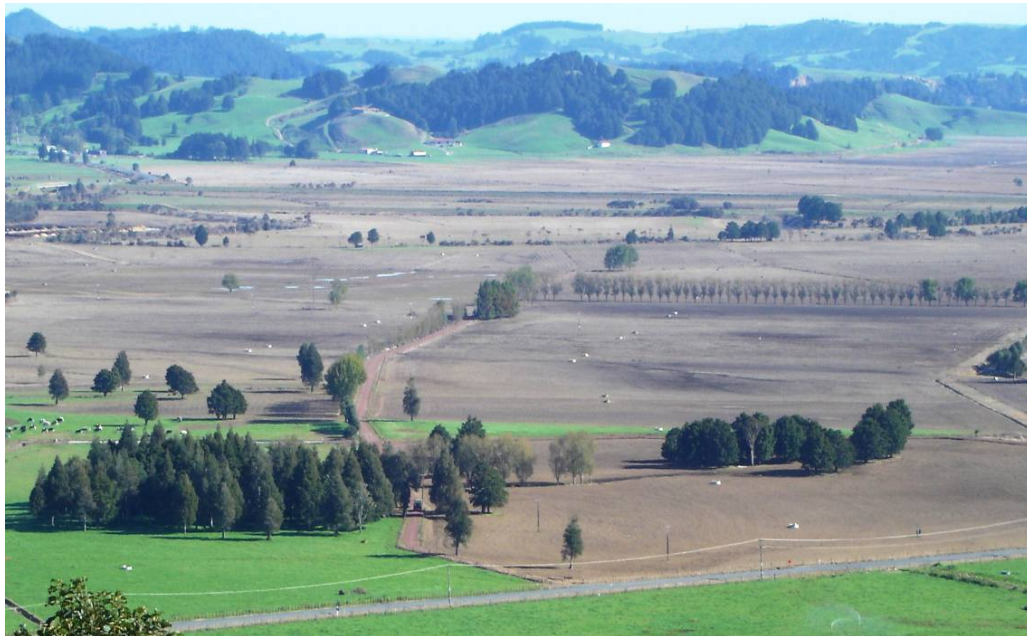
Figure 20: Hikurangi pastures destroyed by long term inundation.

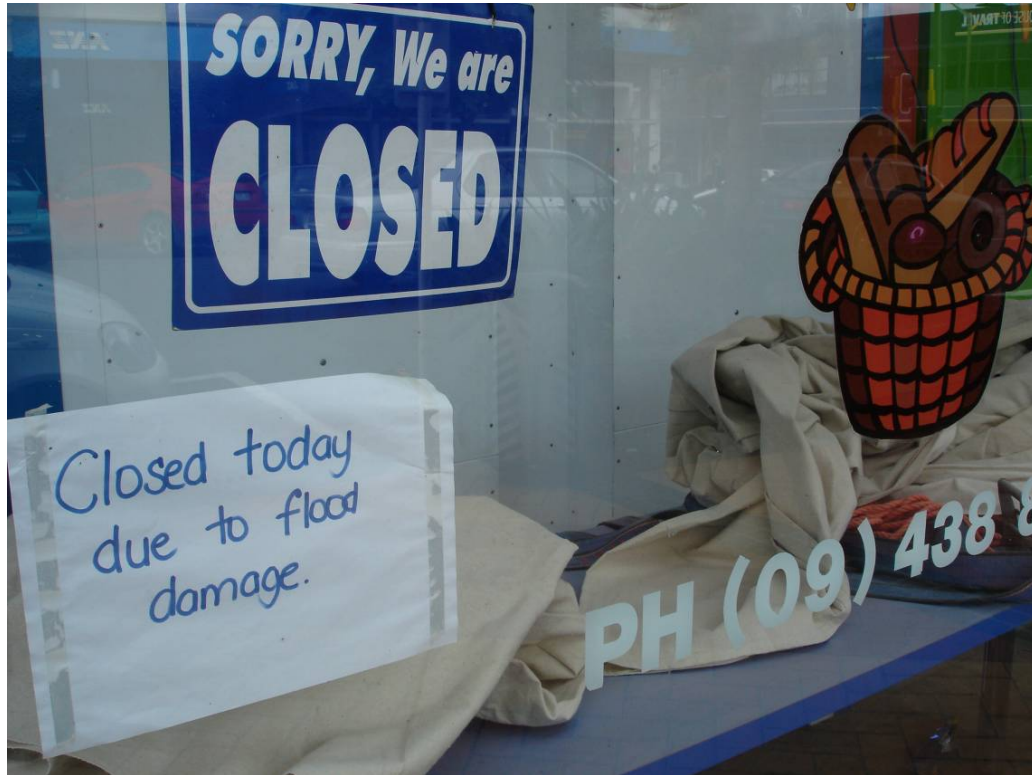
Fortunately the heaviest rainfall intensities stopped short of Whangarei during the March 07 floods and a 1/50-1/80 year event was recorded in the city (Fig. 21). Three rivers flow through Whangarei; the Hatea, the Raumanga Stream and the Waiarohia Stream. A major flood destroyed the Hatea River station in 1995 and it has not yet been reinstated. Consequently, there is no data available from that river for the March floods. The Raumanga has been monitored since 1979 and a 1/50 year flood peak was recorded at 3.30 pm on 29 March. The Waiarohia has catchments west of the city and the Whau Valley water supply reservoir is situated on this river, 3 km upstream of the city. Although originally designed to include flood storage, the Whau Valley Dam spill level was raised some 20 years ago to provide more water supply storage and the flood detention facility was lost. Fortunately, at the end of March 2007 the Whau Valley Dam was not full. It had around 550,000 m³ of available storage and acted as a flood detention dam. The detention effect of the dam reduced the outflows to only a 1/10 year flood event in the Waiarohia River. The Whau Valley Dam has no inflow gauges and no rain gauges in its catchments. The dam inflow during the March floods can be roughly estimated at a 1/100 year event as the peak reservoir level came within 200 mm of flowing over the crest of the emergency spillway which starts to operate in a 1/150 year event.

Figure 21: Whangarei City got off lightly this time.
