Recreational Swimming Water Quality in Northland

Summer 2017-18

1. Executive Summary

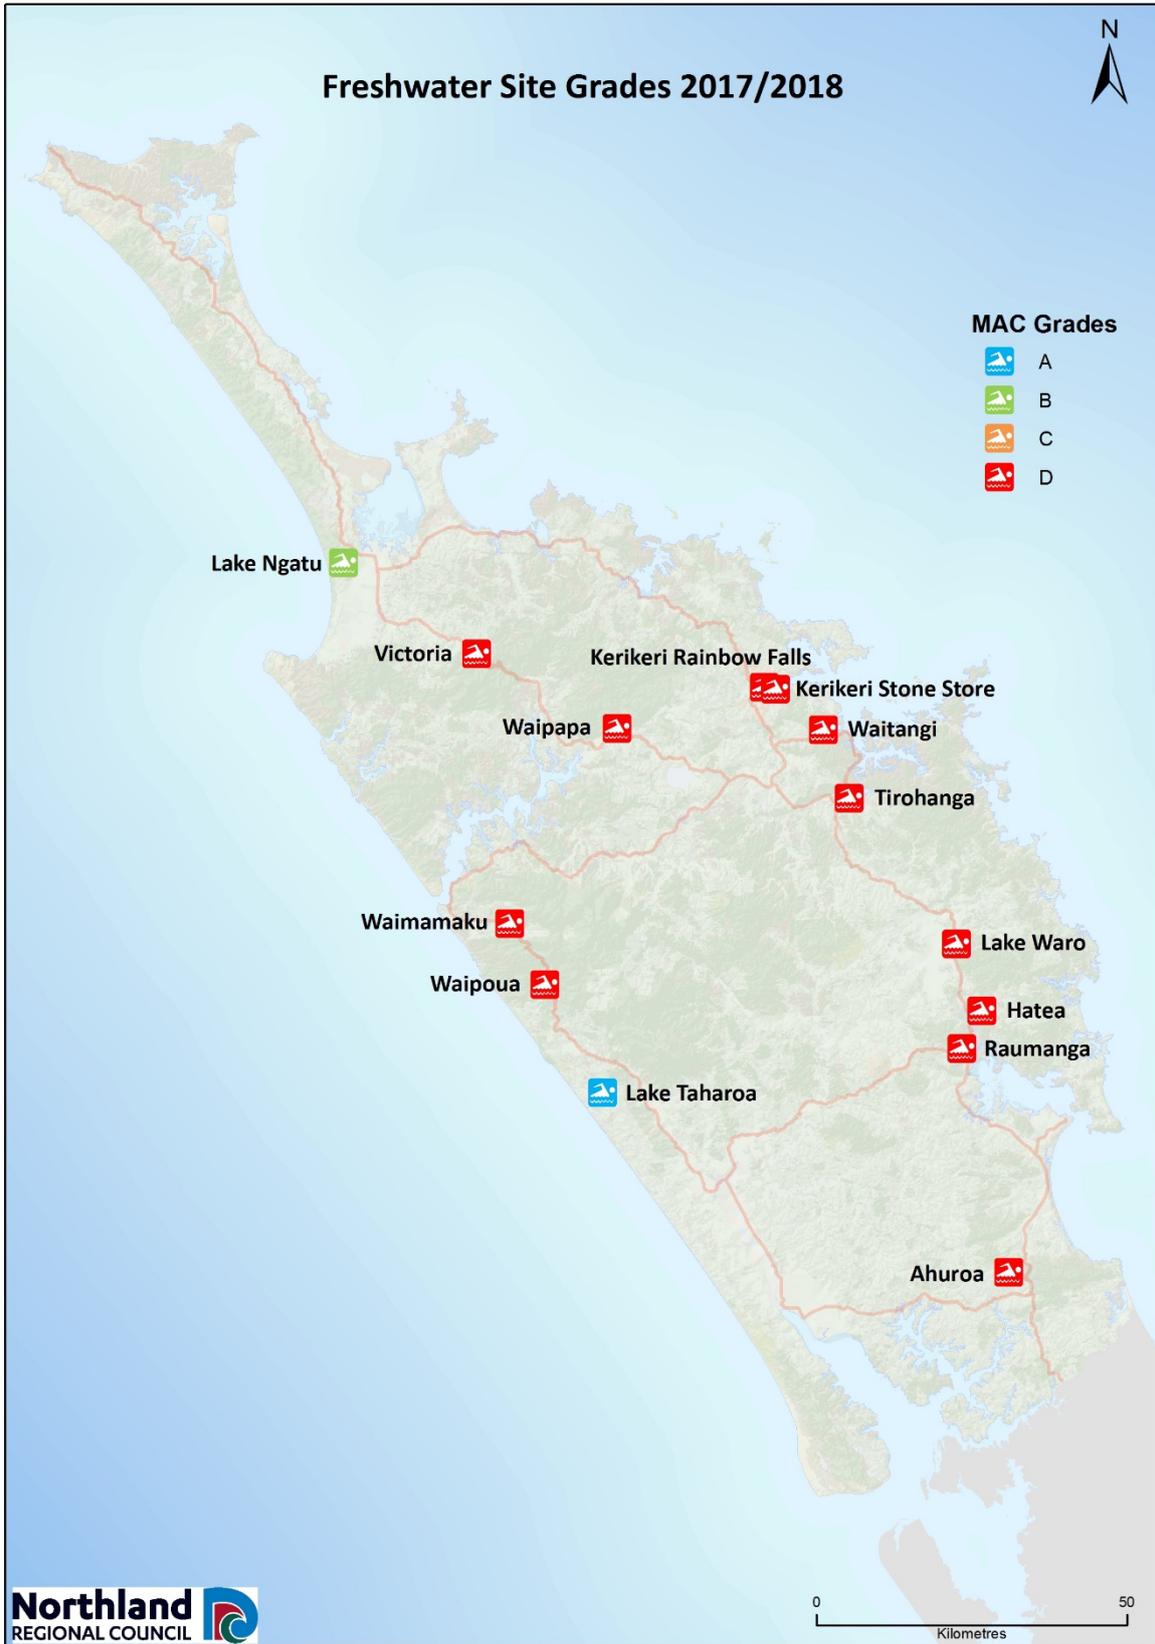
Figure 3: Freshwater end of season grading 2017-18

The map above summarises the end of season grading for samples taken from each of the 14 freshwater sites monitored in Northland during the 2017-18 sampling season (4 December 2017 to the 6 March 2018). The grades indicate the percentage of results below 'Action' level recorded at each site.
