Recreational Swimming Water Quality in Northland

Summer 2013-2014

Jean-Charles Perquin

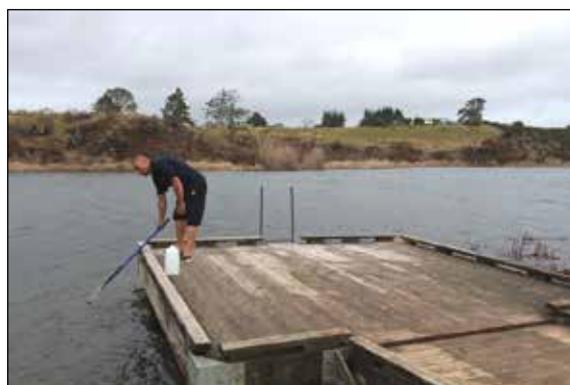
Photo 4: Council staff taking water sample at Lake Waro

Each sample is collected following the methods described in the MfE and MoH (2003) guidelines. Coastal water samples are taken from the shore using a sampling pole at about 0.5 metre depth, from approximately 15 centimetres below the surface. Freshwater samples are taken at approximately 30 centimetres below the surface, at approximately one metre depth. All samples are collected during

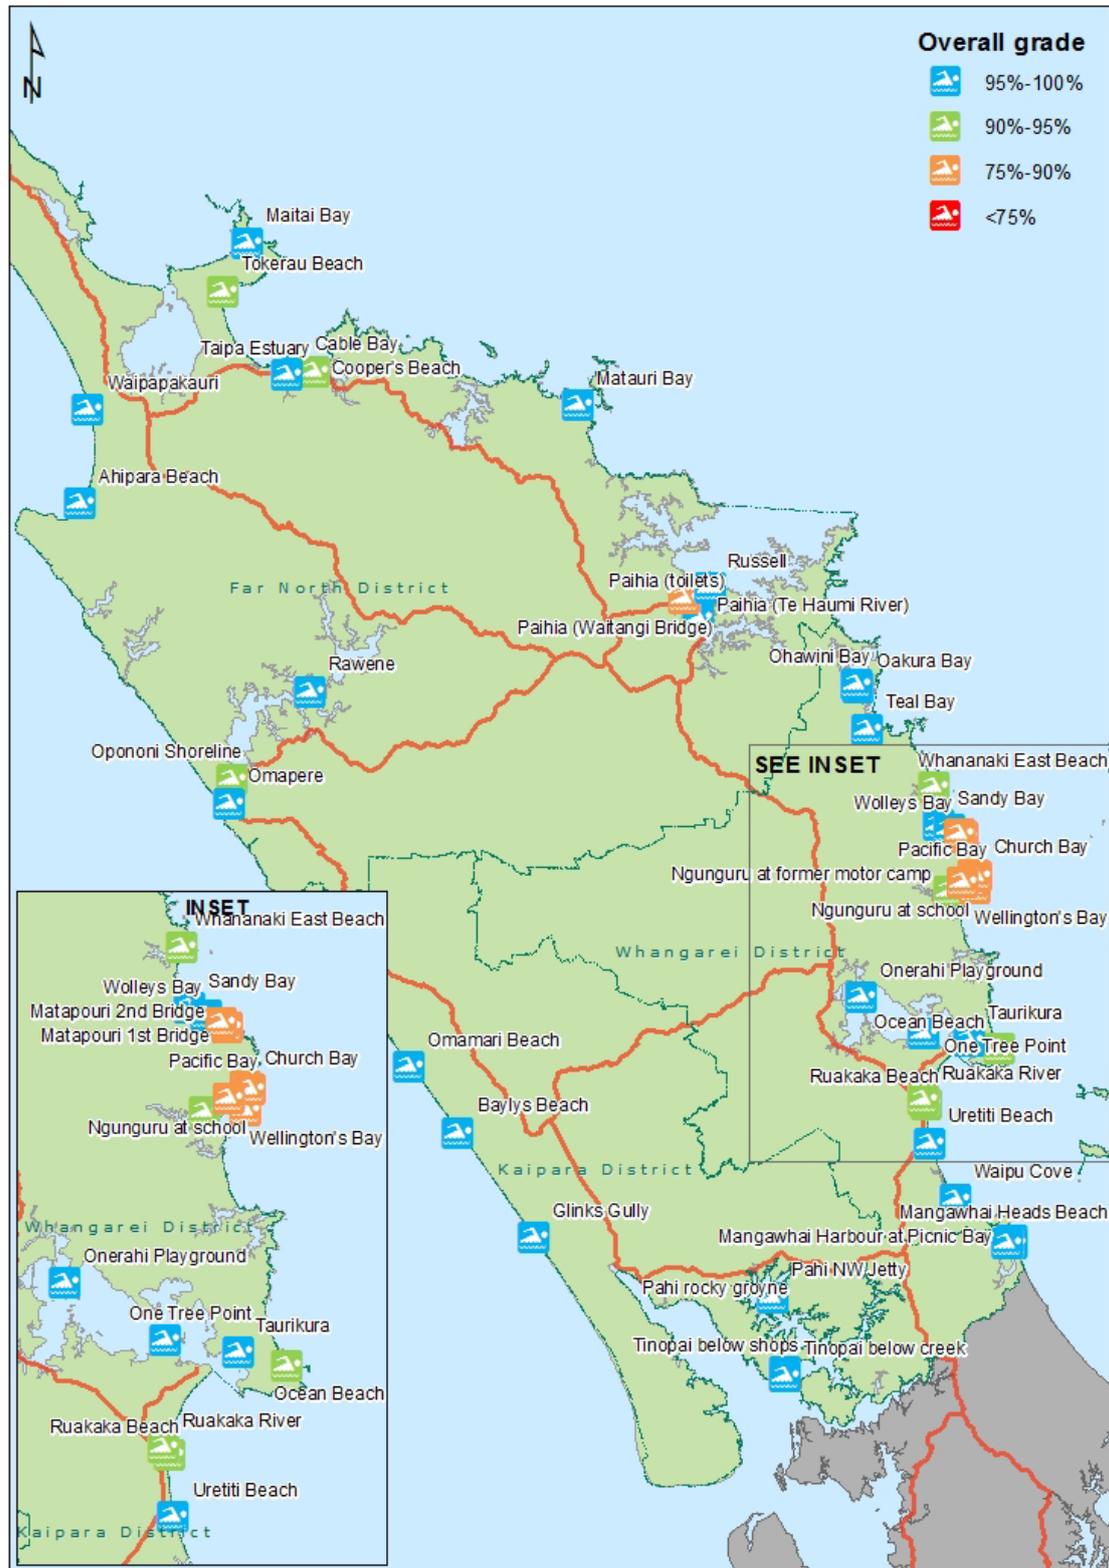
Figure 1: Coastal end of season grading 2013-14

The map above summarises the end of season grading for samples taken from each of the 47 coastal sites monitored in Northland during the 2013-14 sampling season (25 November 2013 to 10 March 2014). The grades indicate the percentage of results below 'Action' level recorded at each site.

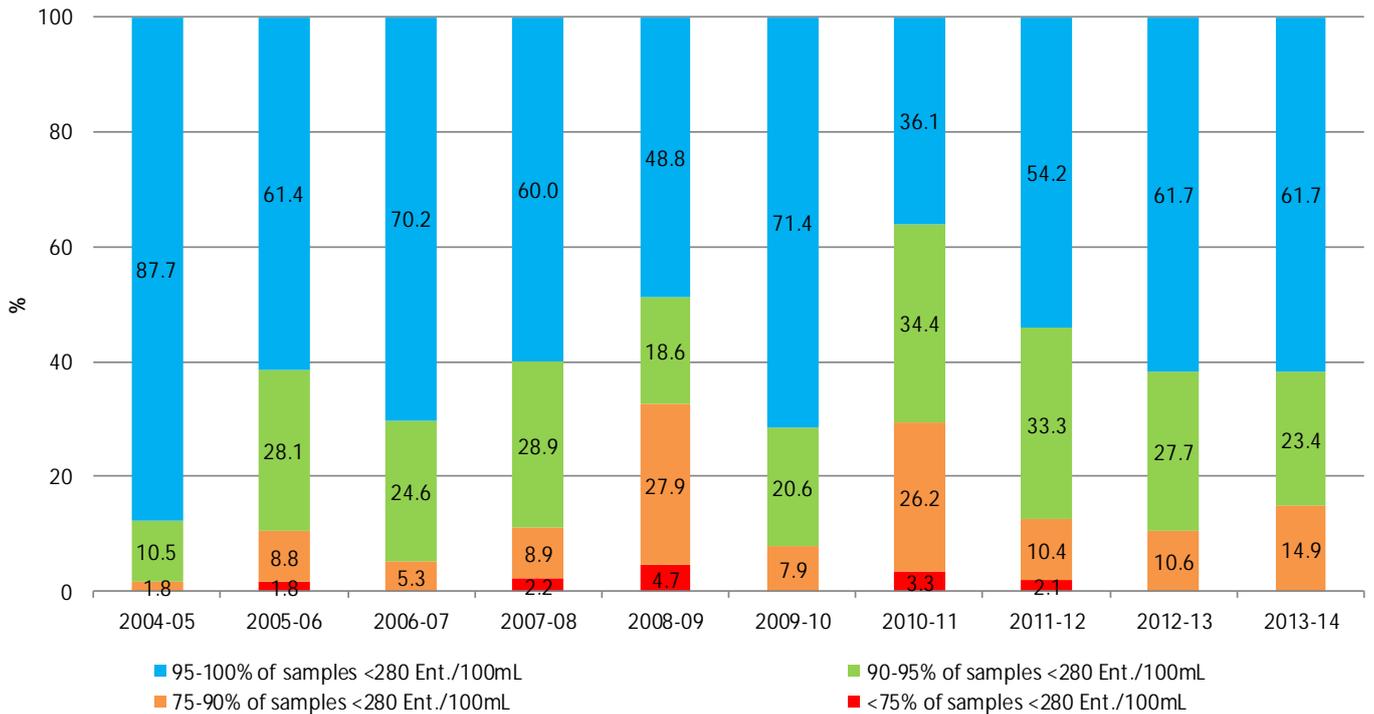
Figure 2: Yearly overall percentage of coastal sites with corresponding percentage of samples within each category from 2004 to 2014

The results from faecal indicator bacteria testing in 2013-14 were comparable to the 2012-13 season. No site recorded less than 75 percent of samples below the 'Action' level, i.e. 280 Enterococci per 100 millilitres. About 62 percent of coastal sites had more than 95 percent of samples below the 'Action' level. Similar grades were recorded in summer 2009-10 as shown in Figure 2 above.

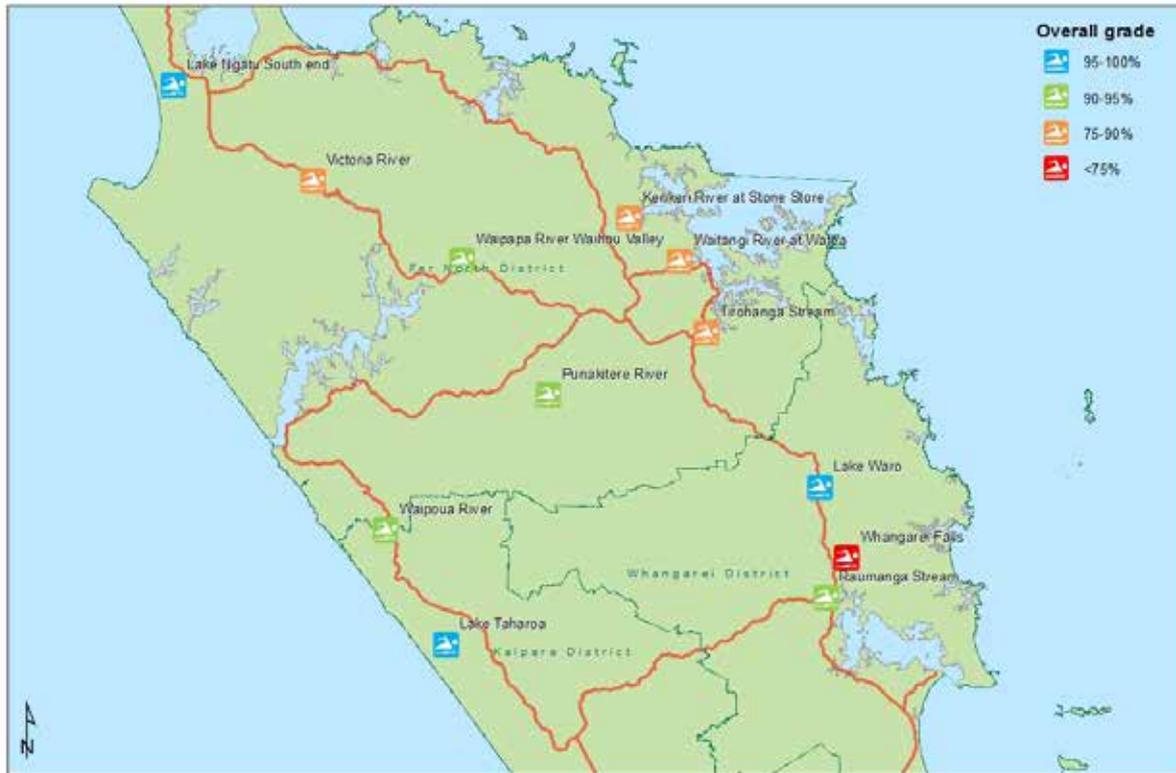
Figure 3: Freshwater end of season grading 2013-14

The map above summarises the end of season grading for samples taken from each of the 12 freshwater sites monitored in Northland during the 2013-14 sampling season (25 November 2013 to the 10 March 2014). The grades indicate the percentage of results below 'Action' level recorded at each site.

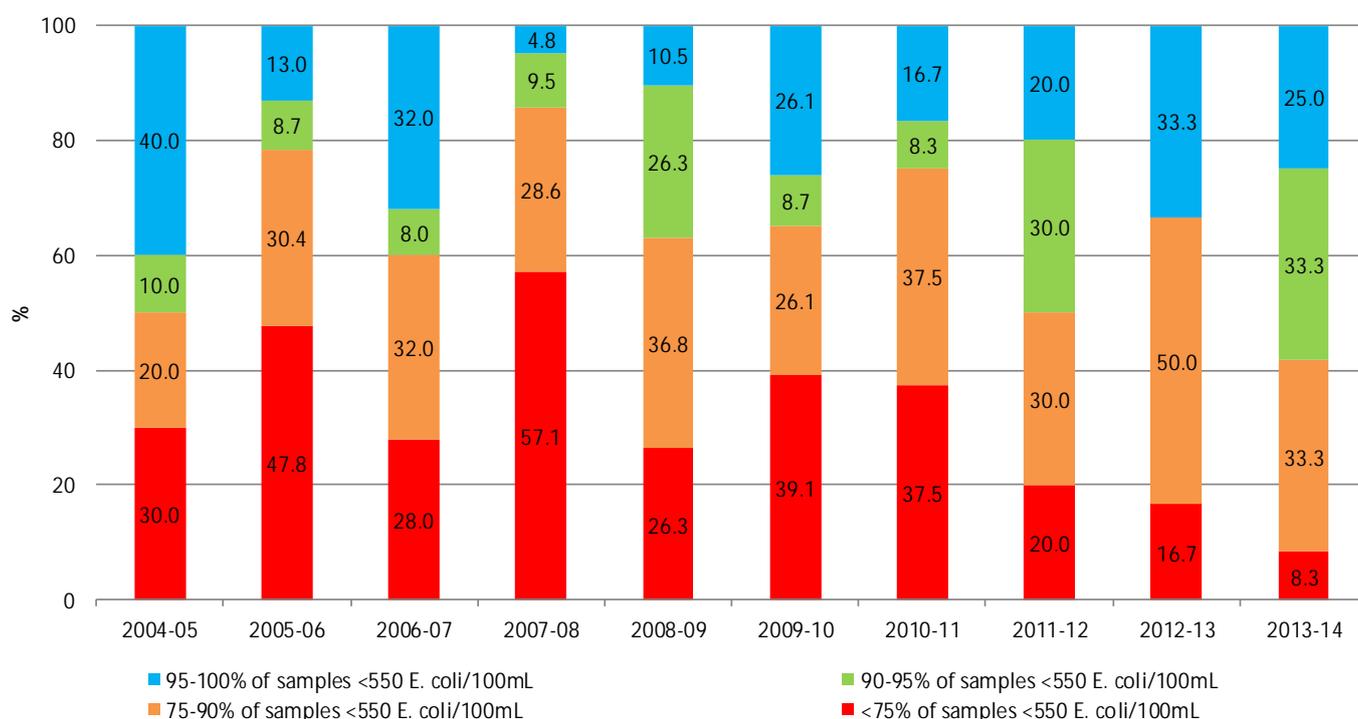
Figure 4: Yearly overall percentage of freshwater sites with corresponding percentage of samples within each category from 2004 to 2014

The results from faecal indicator bacteria testing in 2013-14 were marked by the higher proportion of sites, i.e. 58 percent compared to 33 percent in 2012-13, which recorded between 90 to 100 percent of samples collected below 'Action' level. Also, only 8.3 percent of monitored freshwater sites had less than 75 percent of samples collected below 'Action' level compared to 17 percent in 2012-13. Overall, end of season grades for freshwater sites in 2013-14 were the best recorded to date.
