# Northland Lakes - Annual Report 2014

Prepared for Northland Regional Council

NIWA Client Report No: HAM2014-081  
Report date: June 2014  
NIWA Project: NRC14205

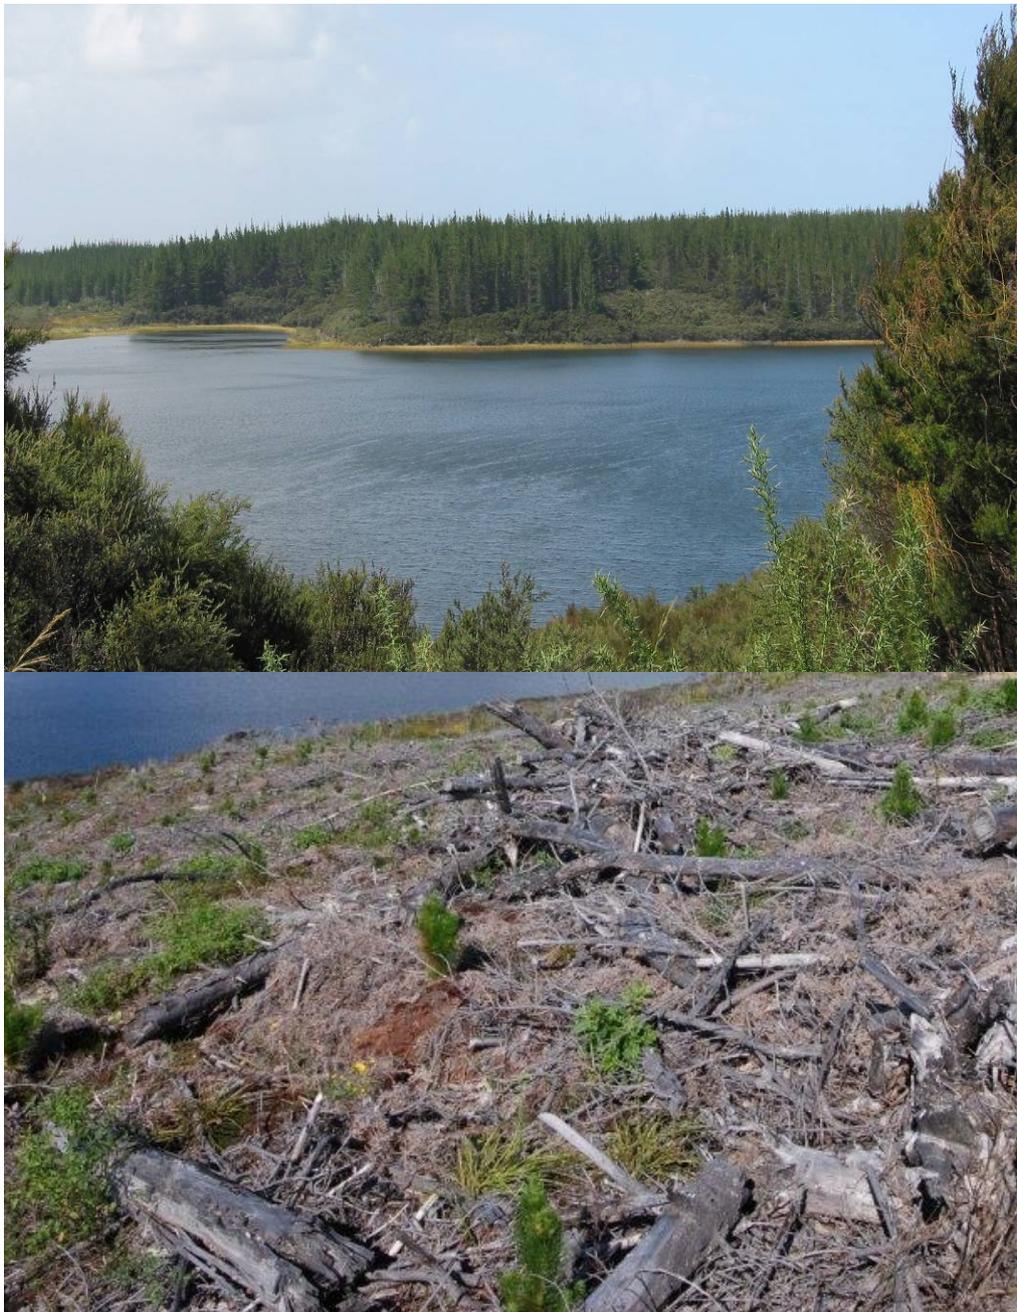
**Plate A: Lake Morehurehu set in mature plantation pine (top 2009), but recently felled and re-planted (bottom 2013).**

Undertake a full investigation of the impact of logging on Lakes Te Kahika, Morehurehu and Morehurehu South 2. Review recent changes in the catchment and document impacts in all receiving waters. Continue lake monitoring annually to evaluate rate of recovery in these lakes. Provide advice to forestry companies or other land-use in these poorly buffered water bodies to modify activities that caused such extensive environmental damage. There are still significant areas in the catchment that have not been felled.

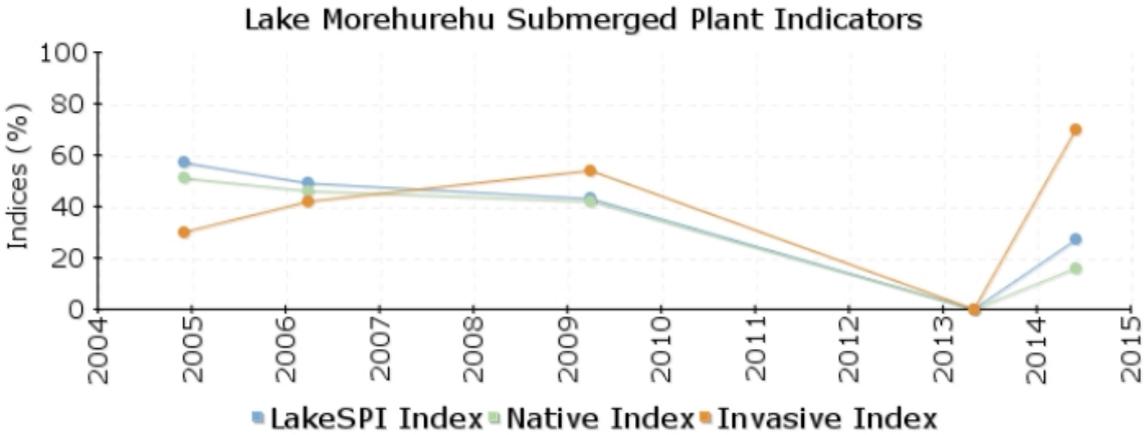
Survey Date	Status	LakeSPI %	Native Condition %	Invasive Impact %
May 2014	Moderate	27%	16%	70%
April 2013	Non-vegetated	0%	0%	0%
March 2009	Moderate	43%	42%	54%
March 2006	Moderate	49%	46%	42%
November 2004	High	57%	51%	30%

LakeSPI indices have deteriorated since 2004. The apparent recovery in 2014 was very minor.

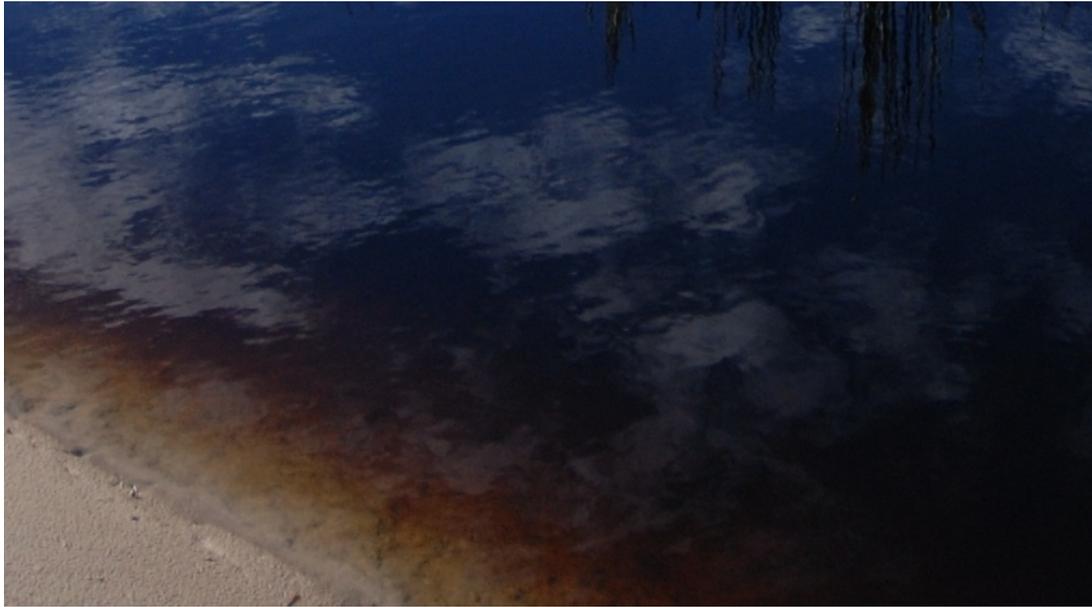
**Plate B: Lake Morehurehu** with dark brown / red stained water and less than 1 m in water visibility.

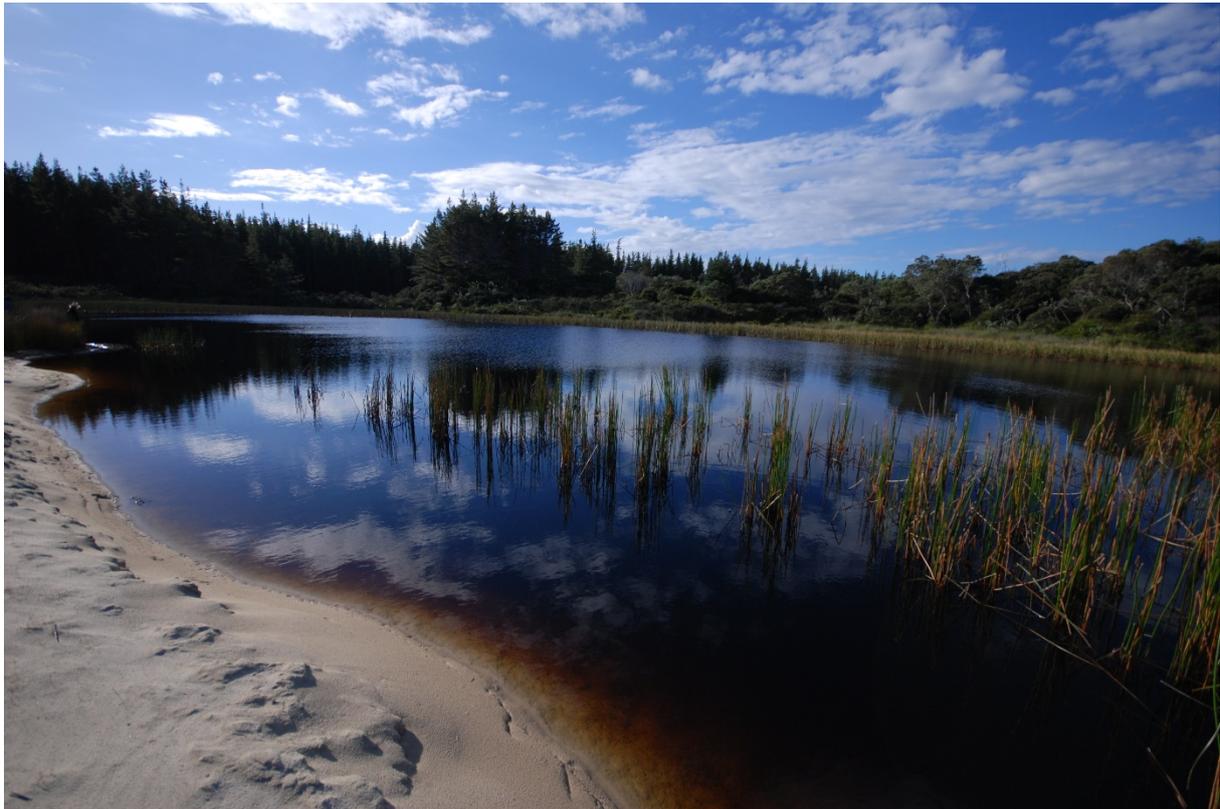
Based on the 2006 survey a Lake Ecological Value rating of 10 (High) was calculated. A deterioration in the rating of the following parameters: aquatic vegetation diversity and integrity (essentially a loss of submerged vegetation, with a decline of diversity from 1 to 0 and integrity from 3 to 0) and endangered species (loss of *U. australis*) has resulted in a revised score of 5 (Moderate). Water quality was not measured at this lake but water transparency had declined (Plate B).

**Plate B: Morehurehu South 2 April 2013** with no pine harvesting in the immediate catchment. This lake has never-the-less deteriorated from clear (>3 m transparency) to very dark brown (< 0.5 m transparency) as did other lakes in the catchment following pine harvesting. By 2014 the water was clear (~2.5 m) again.

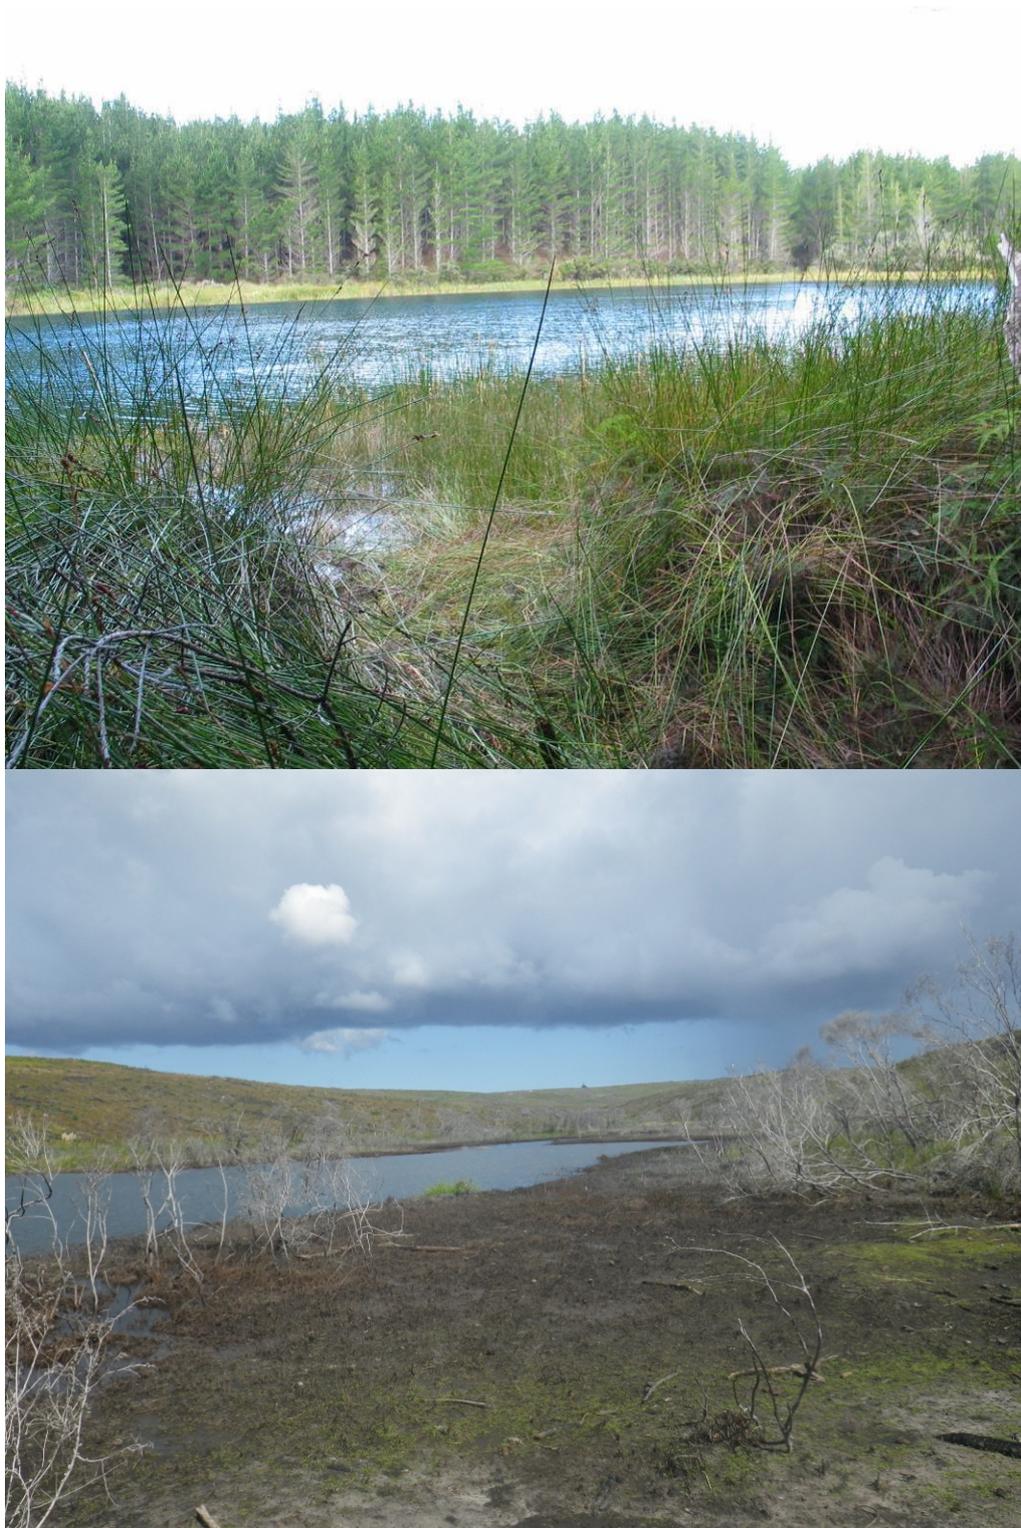
**Plate A: Lake Te Kahika set in a mature plantation pine catchment (top 2009); now de-forested and a section of shore line wetland vegetation affected by fire (bottom 2013).**

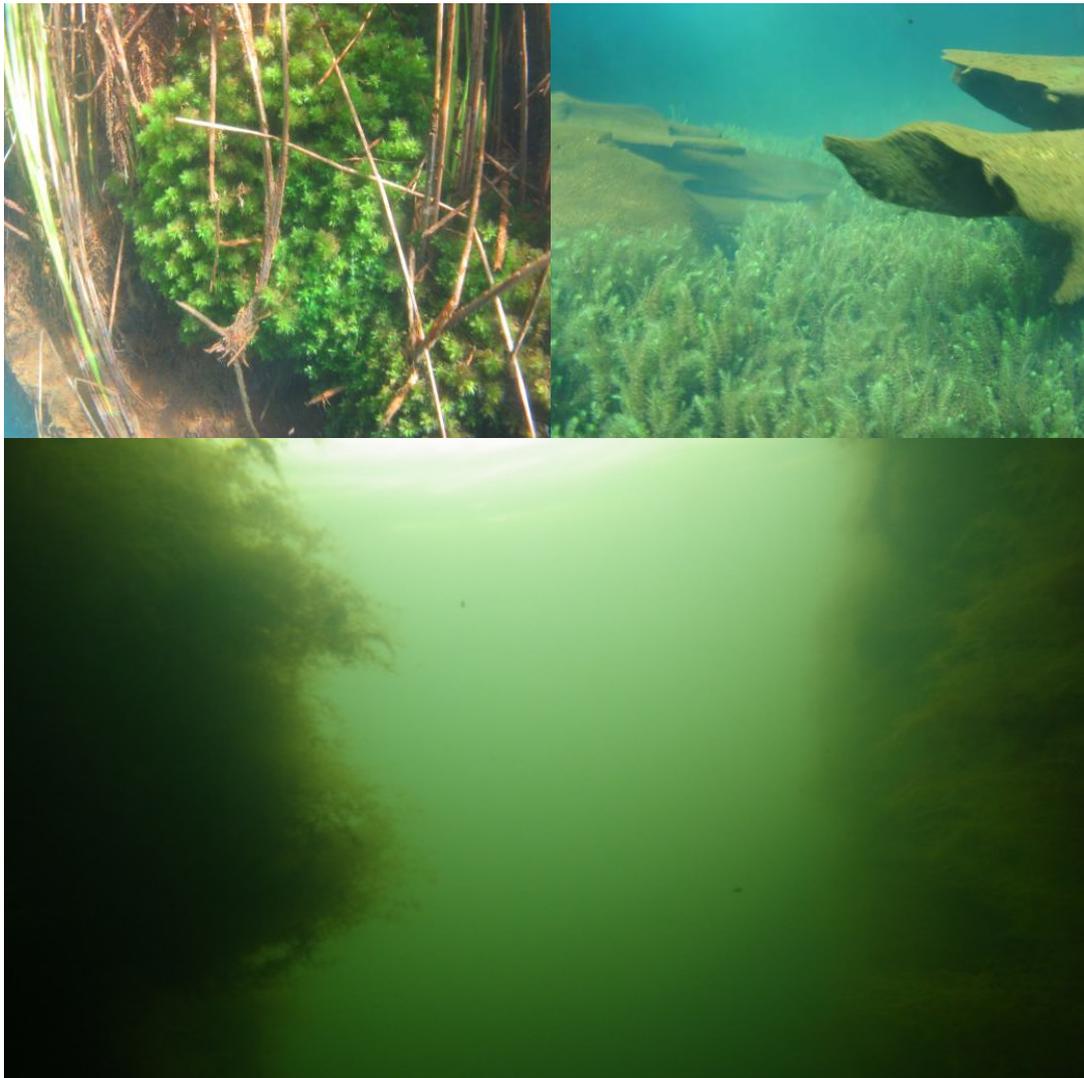
Since 2009 the invasive *Utricularia gibba* has extensively colonised the lake margins to a maximum depth of 4 m (Plate B). In 2013 a marked drop in water clarity was noted and prevented submerged plant growth at this site. However, *Isolepis fluitans* (previously only recorded from Lake Wahakari) was located at 2 m depth at one location in 2013. In 2014 *U. gibba* was the only submerged species recorded and water clarity remained very poor.

**Plate B: Lake Te Kahika 2009** showing clear water with *Sphagnum* (top left) at 1.0 m deep water in marginal emergent vegetation; a rare sight, *Utricularia australis* (top right) abundant on the bottom of an inflowing stream >3 m deep; and 2013 (bottom), the same location but showing poor water clarity, *U. australis* absent on the bottom and *Sphagnum* replaced by *U. gibba* on the sides.

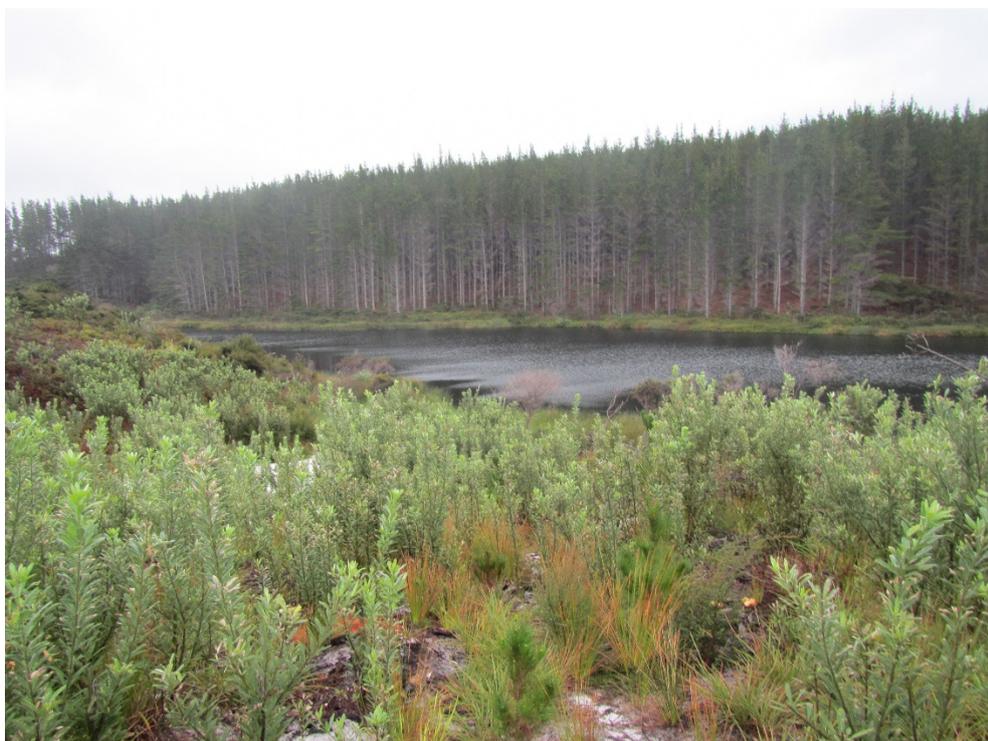
**Plate C: At Lake Te Kahika the pine plantation in the foreground has been clear felled to the lake edge and the area re-planted. *Oxylobium* (*Callistachys lanceolata*) has made a head start and is currently the dominant plant.**

The marked drop in water clarity and rise in total nitrogen concentration is significant and needs further attention to identify the causes and prevent it from re-occurring in future.

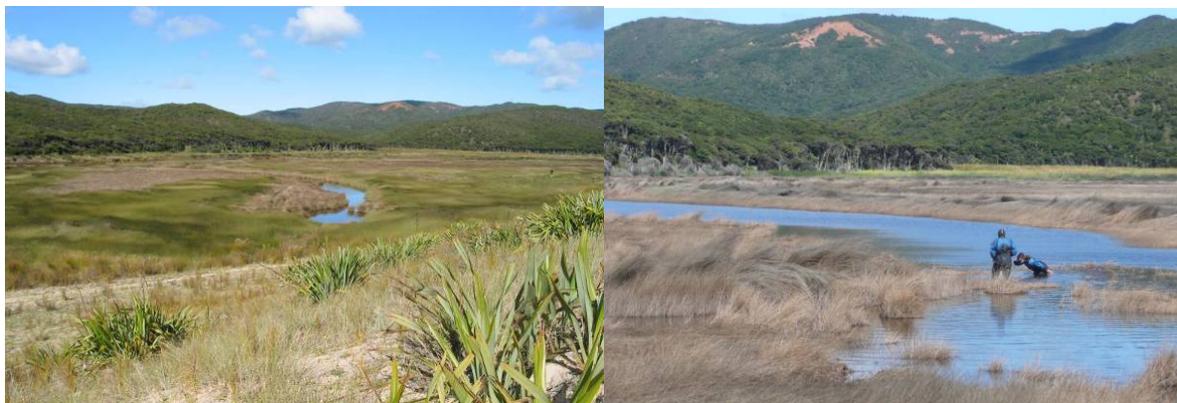
**Plate A: LEFT 2007 showing the east end of Waitahora Lagoon, showing a saline influenced wetland dominated by the green oioi (*Apodasmia similis*) and brown sea rush (*Juncus kraussii* var. *australiensis*). RIGHT 2009 showing a closer of the same area but with the oioi impacted by saltwater intrusion.**

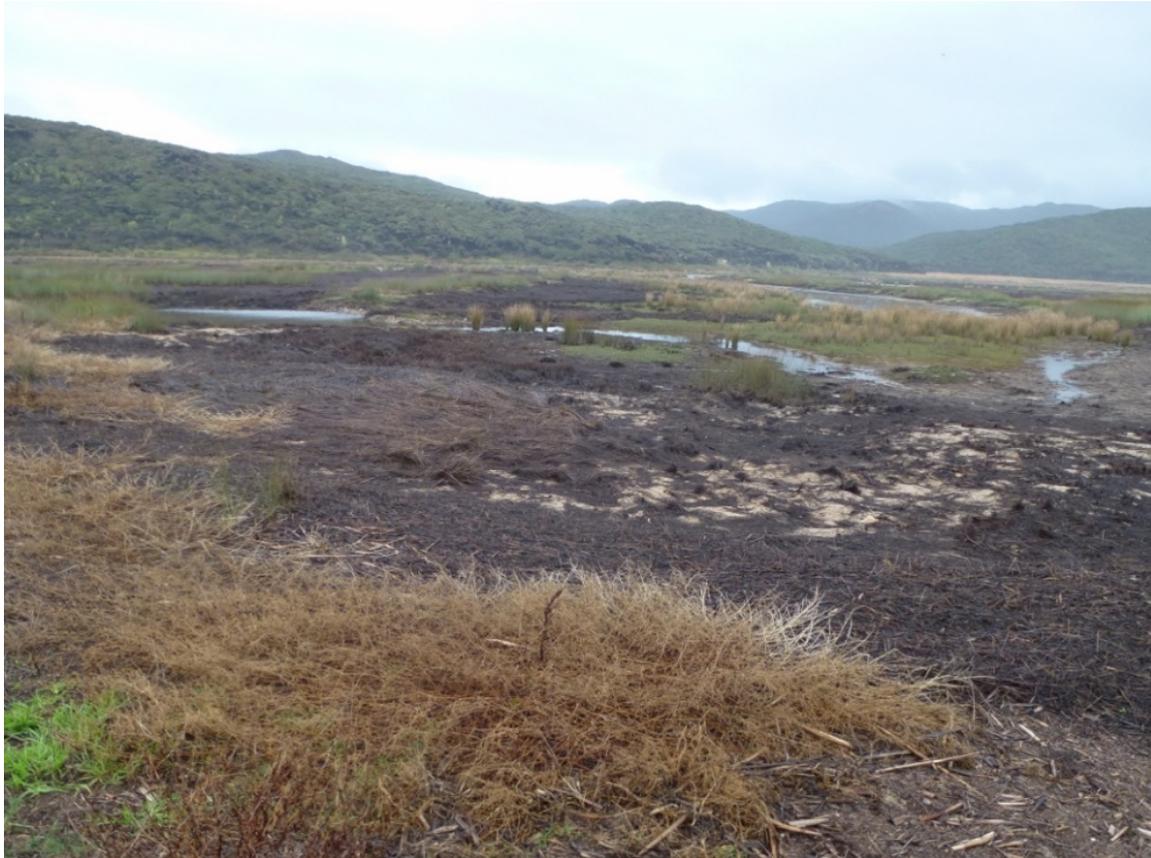
**Plate B: Salt water intrusion has desiccated saline intolerant plants 2014.**

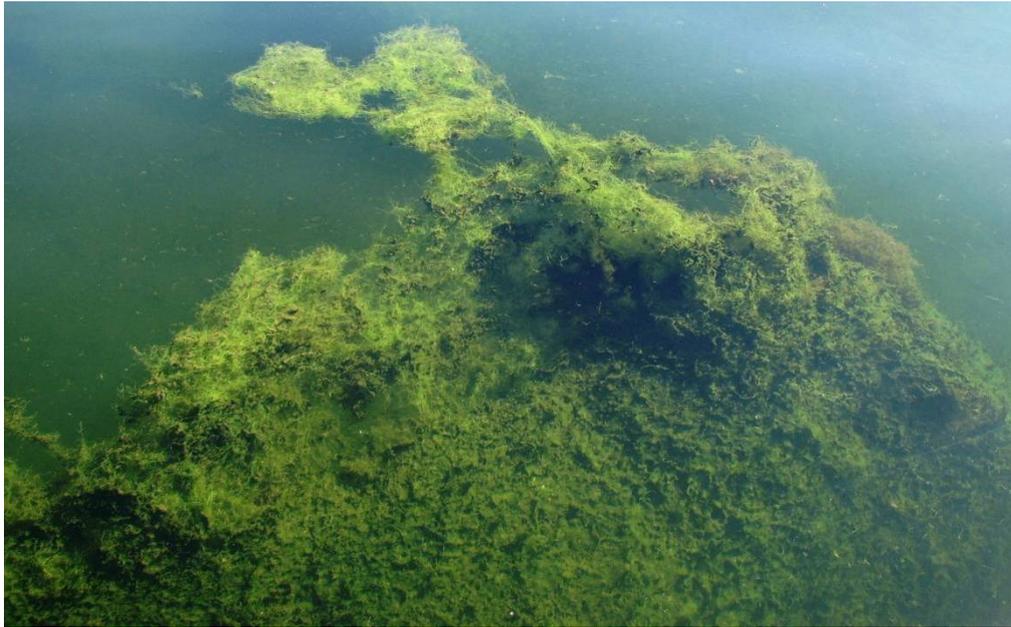
*Utricularia gibba* formed an extensive smothering mat covering the lagarosiphon and indigenous charophyte vegetation to 4.0 m deep. Large mats of *U. gibba* were associated with a periphyton raft up near the water surface in autumn (Plate B). The bladderwort *U. australis* was common within this lake but has not been seen here since 2007.

Plate B: Lake Ngatu, *Utricularia gibba*, an invasive plant pictured in autumn lifting off the bottom and rafting on the surface (photo Kevin Matthews 30 May 2007).

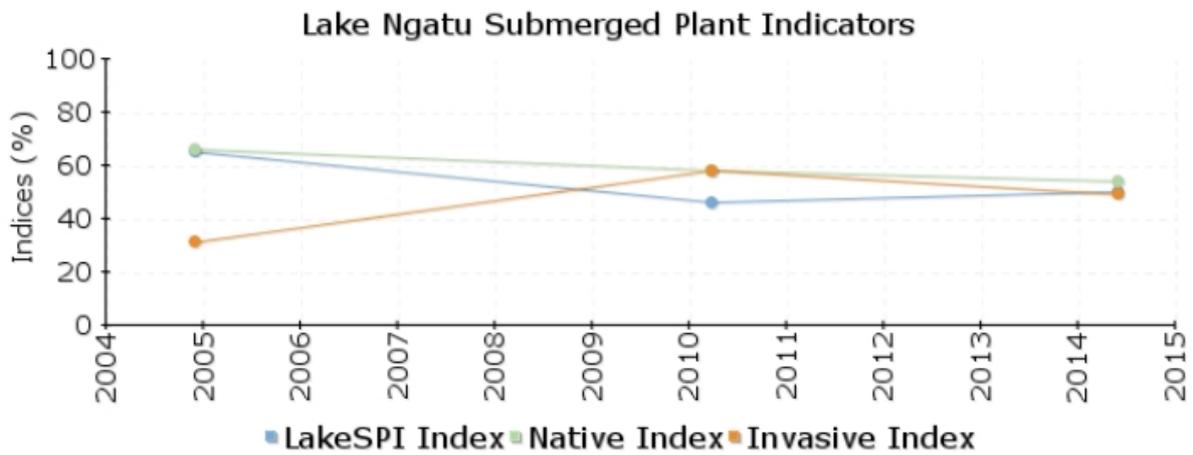
Survey Date	Status	LakeSPI %	Native Condition %	Invasive Impact %
May 2014	Moderate	50%	54%	49%
March 2010	Moderate	46%	58%	58%
November 2004	High	65%	66%	31%

A decrease in LakeSPI score from 65% in 2004 to 46% in 2010 was a result of increasing invasive impact from *U. gibba* and a decrease in native condition. A minor improvement driven by reduced invasive impact is indicated since 2010, but the Native Condition Index has declined slightly.

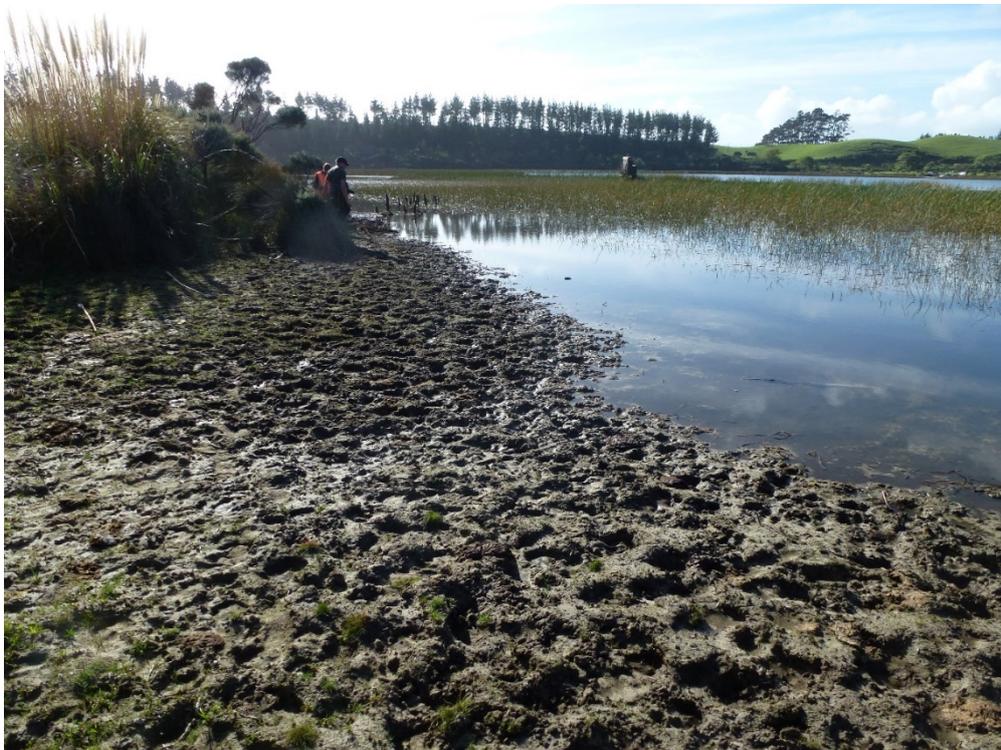
western lake edge allows added nutrients and grazing of emergent vegetation as photographed in 2014 (Plate B).

**Plate B: Cattle pugging and heavy grazing of emergent vegetation on the margin of Lake Rotokawau, May 2014.**

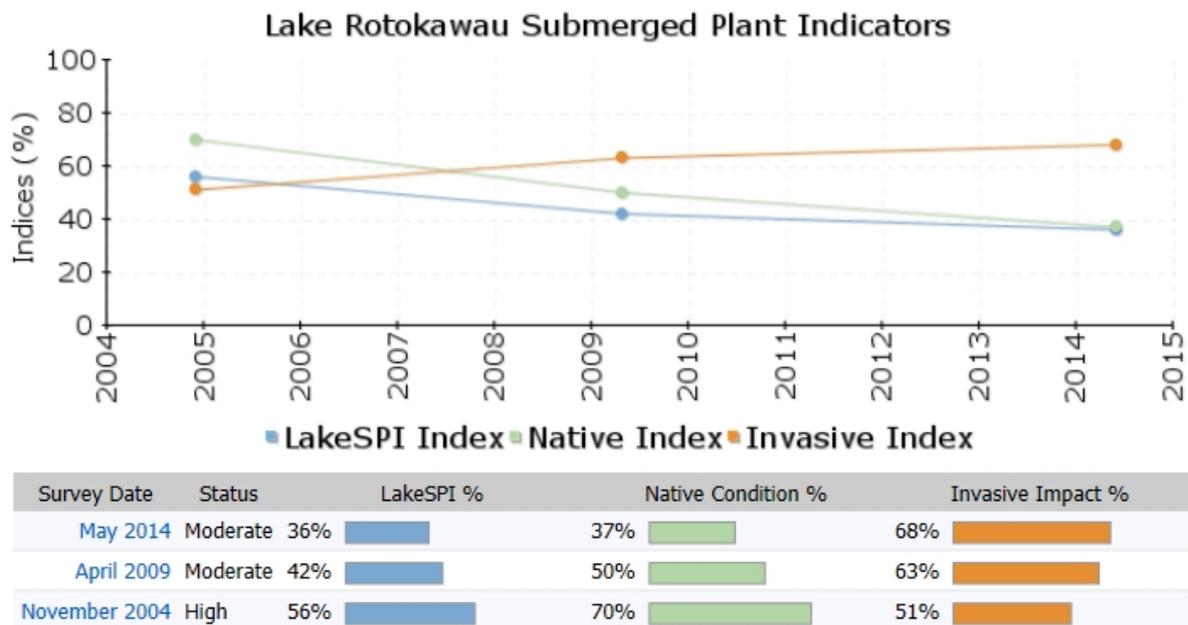
The LakeSPI scores have shown a significant and steady deterioration over time. The invasive *Utricularia gibba* has increased in cover markedly, with a corresponding decrease in charophyte cover.

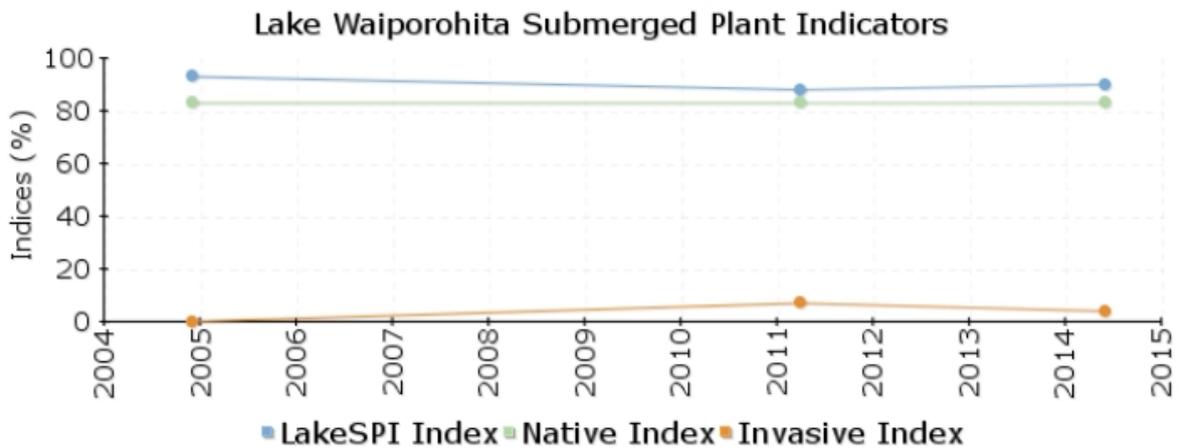
Survey Date	Status	LakeSPI %	Native Condition %	Invasive Impact %
May 2014	Excellent	90%	83%	4%
March 2011	Excellent	88%	83%	7%
November 2004	Excellent	93%	83%	0%

The excellent LakeSPI scores of 88 - 93% reflect the extent of the native vegetation, with limited influence of invasive exotic species. The invasive impact of *Utricularia gibba* was minimal and restricted to shallow water.

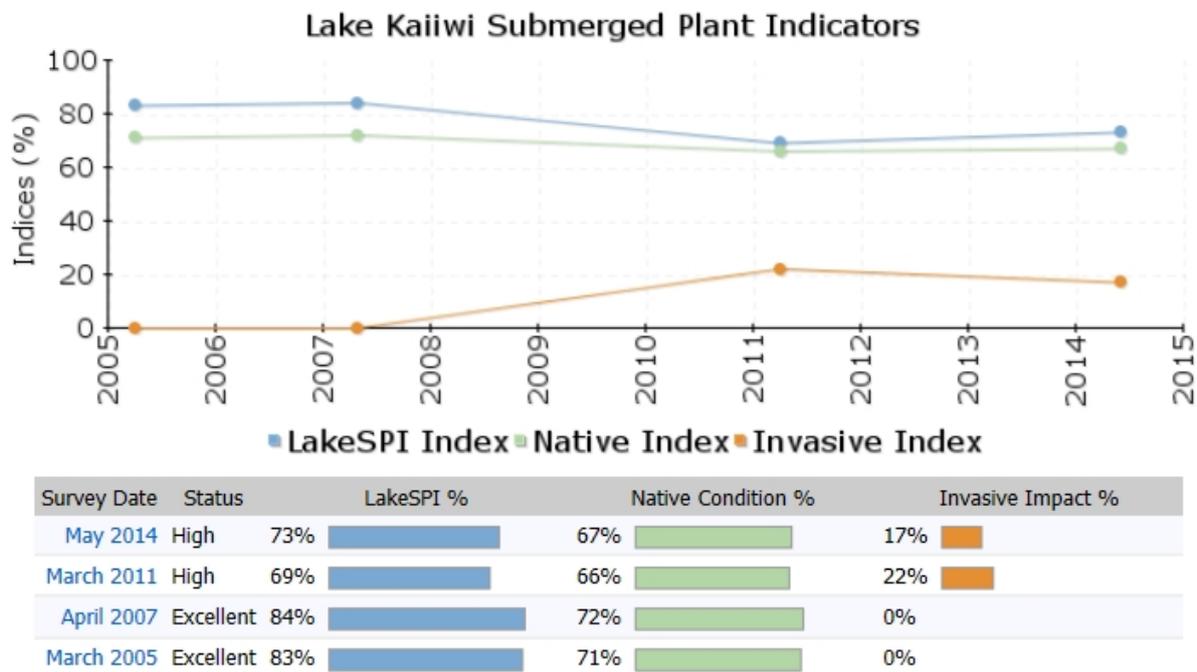
The excellent LakeSPI score in 2007 of 84% reflected the extent of vegetation development, the presence of several key native plant communities and absence of invasive exotic species. However, in 2011 *U. gibba* presence reduced the LakeSPI score to 69% and increased the invasive score to 22%. The impact of *U. gibba* reduced in 2014 with subsequently improved LakeSPI scores.

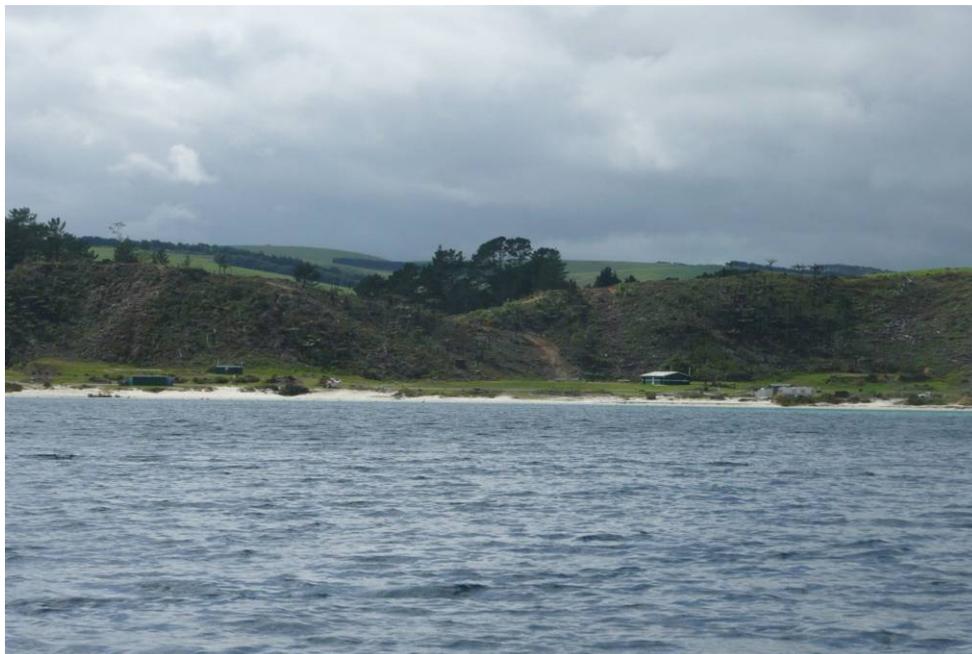
**Plate A:** Lake Taharoa shoreline at the south end showing the motor camp in 2011. Note the exposed beach, the paucity of emergent vegetation and the pine tree removal.

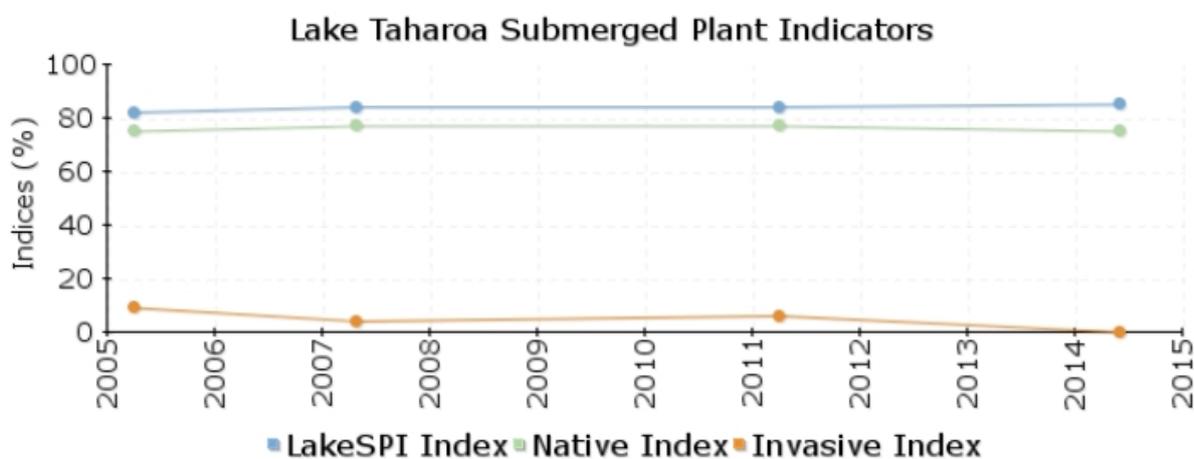
Survey Date	Status	LakeSPI %	Native Condition %	Invasive Impact %
May 2014	Excellent	85%	75%	0%
March 2011	Excellent	84%	77%	6%
April 2007	Excellent	84%	77%	4%
March 2005	Excellent	82%	75%	9%

An 'Excellent' LakeSPI score of 85% reflects the depth extent of vegetation, the predominance of the native charophyte community and minimal impact by invasive exotic plants. Lake condition remains Excellent and very stable.

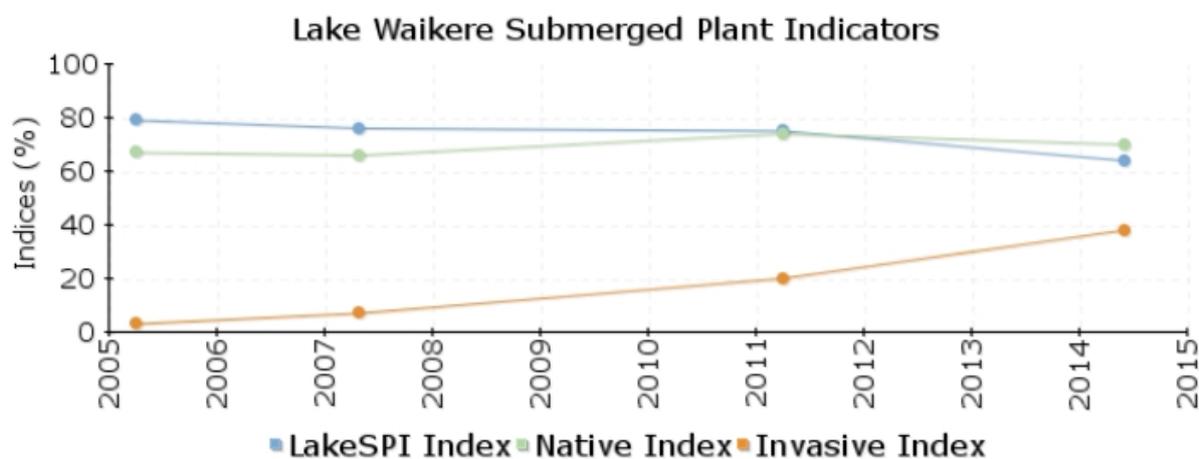
Survey Date	Status	LakeSPI %	Native Condition %	Invasive Impact %
May 2014	High	64%	70%	38%
March 2011	High	75%	74%	20%
April 2007	Excellent	76%	66%	7%
March 2005	Excellent	79%	67%	3%

A 'High' LakeSPI score of 64% was driven by the large extent of native vegetation and presence of charophyte meadows but with impact from invasive deep-growing *U. gibba* increasing the Invasive Index of this lake from 3% in 2005 (derived from *Juncus bulbosus* impact) to 38%.

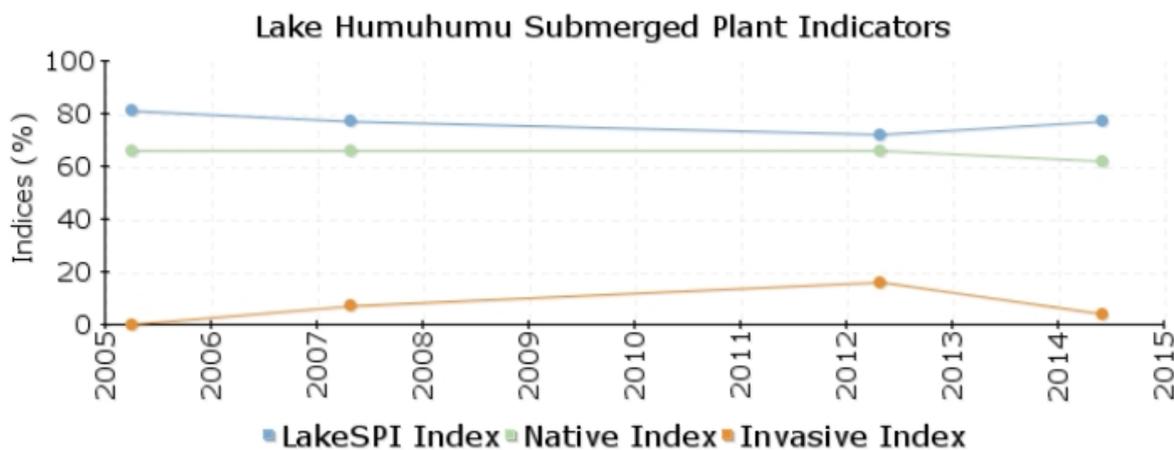
Survey Date	Status	LakeSPI %	Native Condition %	Invasive Impact %
May 2014	Excellent	77%	62%	4%
April 2012	High	72%	66%	16%
April 2007	Excellent	77%	66%	7%
March 2005	Excellent	81%	66%	0%

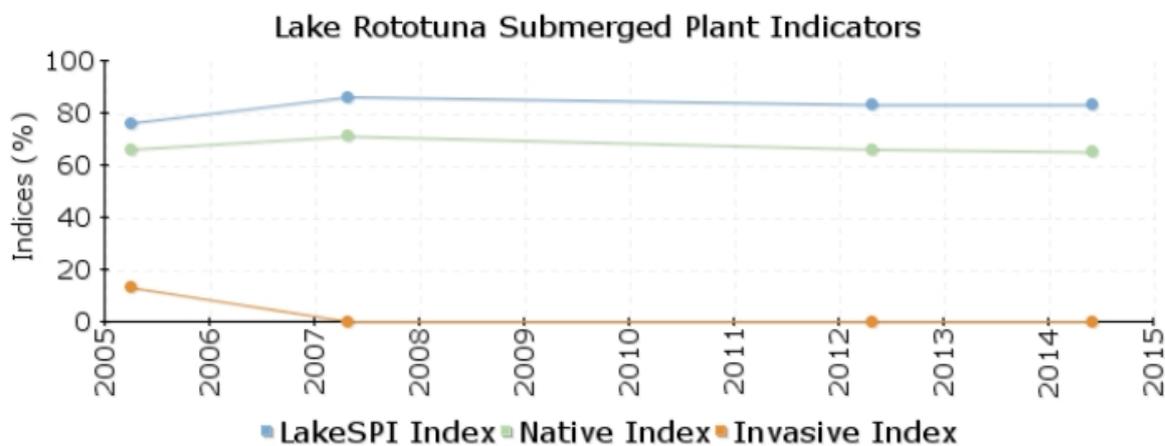
Survey Date	Status	LakeSPI %	Native Condition %	Invasive Impact %
May 2014	Excellent	83%	65%	0%
April 2012	Excellent	83%	66%	0%
April 2007	Excellent	86%	71%	0%
March 2005	Excellent	76%	66%	13%

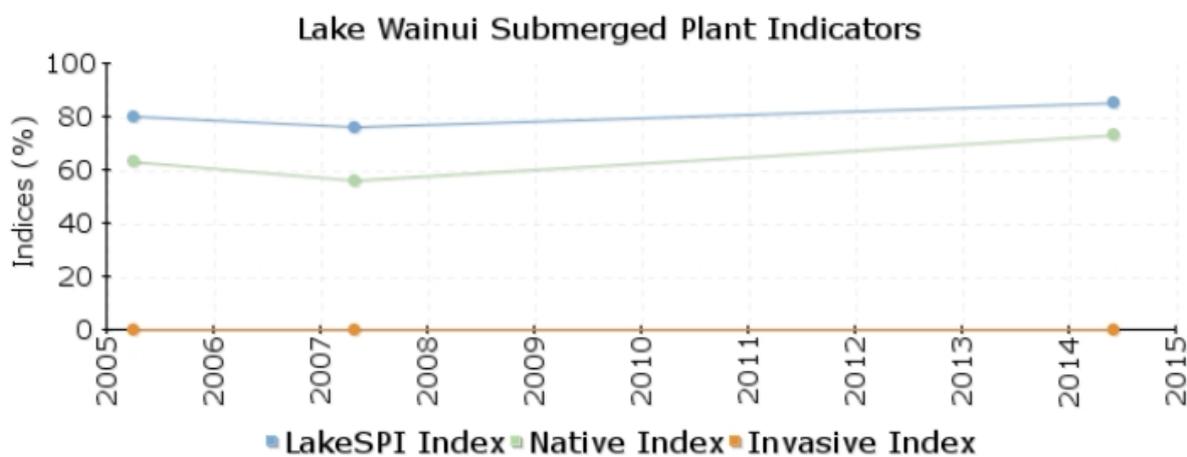
Survey Date	Status	LakeSPI %	Native Condition %	Invasive Impact %
May 2014	Excellent	85%	73%	0%
April 2007	Excellent	76%	56%	0%
March 2005	Excellent	80%	63%	0%

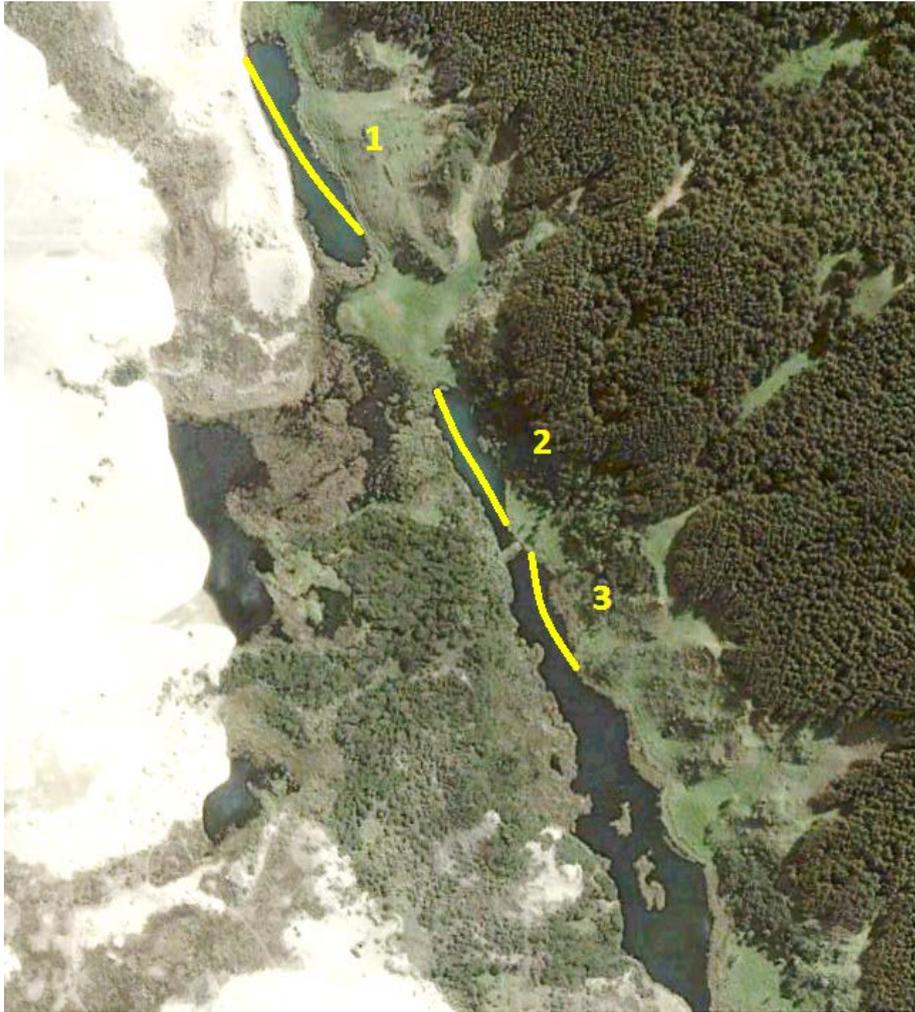
**Plate B: Yellow lines indicate path swum. Line 1 is Round Hill Lake 2, and lines 2 & 3 are paths swum in Lake Wairere (north end).**

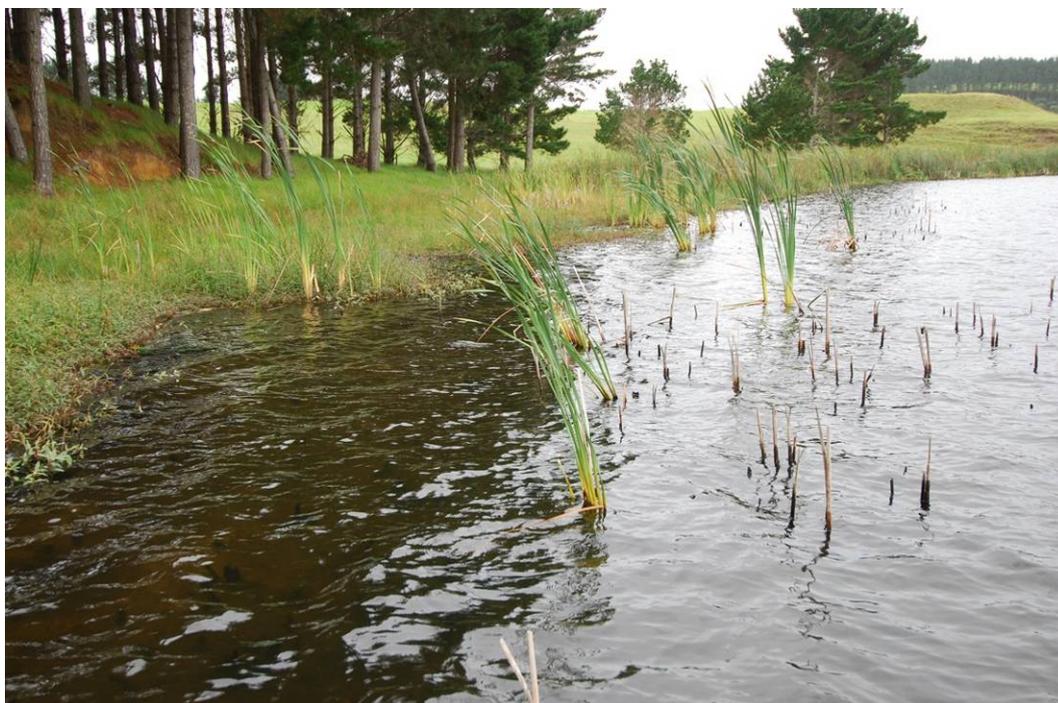
**Plate B: Lake Swan margins.** Grass carp were introduced in May 2009 and by 2011 had removed significant amounts of the raupo (*Typha orientalis*) from the margins.

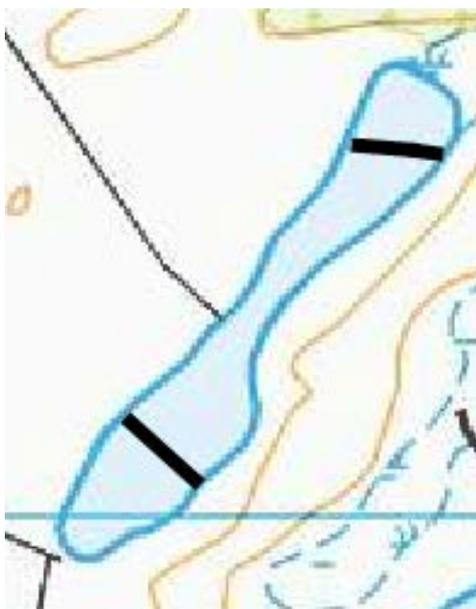
The two baseline profiles recorded prior to grass carp release in 2010 were repeated in subsequent years (Plate C).

**Plate C: Lake Heather** showing the location of the 2 profiles monitored, with one in each basin.

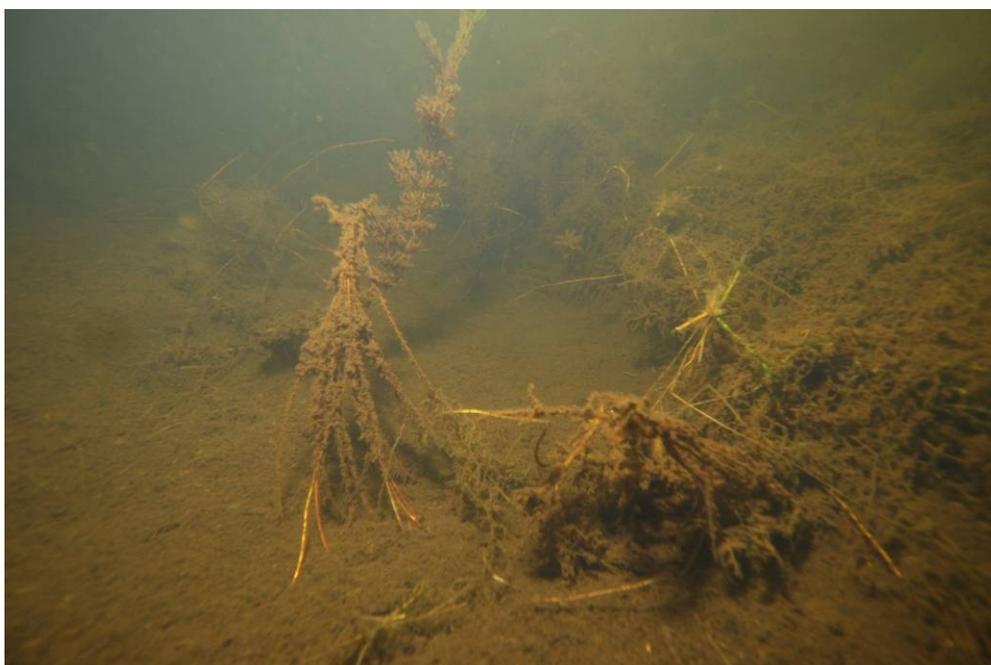
In the first year egeria had been heavily grazed but little damage was noted on the hornwort (in 2011). During the following year to April 2012, egeria had been reduced to basal stalks (Plate D) and about 50% of the hornwort was removed with much of it still up to 2.2 m tall.

**Plate D: Egeria (*Egeria densa*) remnants 2011 in Lake Heather** at 2.6 m deep heavily grazed by grass carp.
