Poutō Peninsula

Rotopouua (Poutō), NRC Lake No. 348.

Summary	Rotopouua
Surveyed:	2008, 2012 and 2018.
Overall ranking:	High: a small dammed lake with a well buffered margin and well-developed submerged vegetation community, with minor invasive species impact.
Threats:	The restricted access to this lake reduces the threat of introduction of pest plants. Water quality continues to be poorer than expected, considering the intact submerged vegetation present in the lake. Several extensive pugged wetland areas were noted on the northern side of the lake that would contribute to deteriorating water quality.
Management recommendations:	5 yearly assessment of lake native biodiversity value is recommended. Analysis of nutrient sources to the lake would allow mitigation of ongoing eutrophication. Fencing and potentially planting of wetland areas to intercept nutrient rich runoff is suggested.

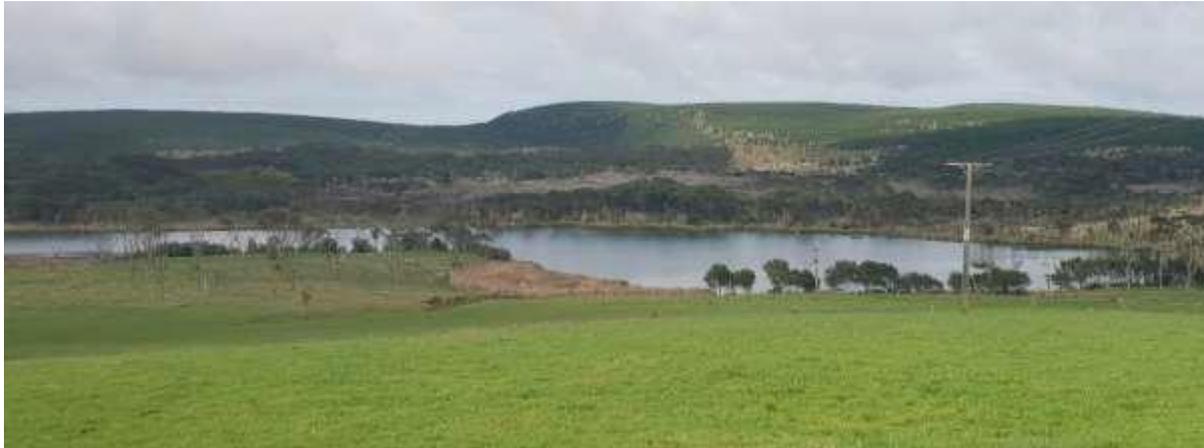
Rotopouua. Photo showing the pasture catchment to the east (foreground) with native scrub and pine forest to the east. (Photo: Tracey Burton 21 September 2018).

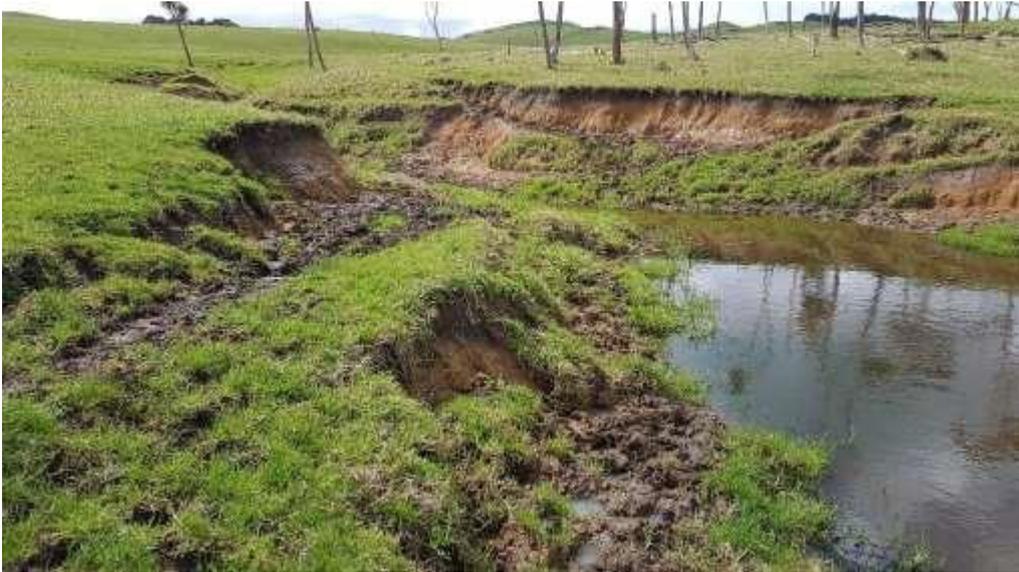
Water quality continues to be poorer than expected, considering the intact submerged vegetation present in the lake. The heavy rainfall prior to and during the 2018 survey allowed investigation of point sources of nutrients running off from farmland. Several extensive pugged wetland areas were noted on the northern side of the lake that would contribute to deteriorating water quality. These were compared with a fenced inlet at the western end of the lake which was completely vegetated allowing processing of nutrients.

Unfenced inflow to Rotopouua. (Photo: Paul Champion 21 September 2018).

Analysis of annual monitoring of water quality should be undertaken to determine the extent of nutrient enrichment and consideration of sources of nutrients to the lake. This analysis may find a means of mitigating the nutrient enrichment threat from inflows and drains. Fencing and potentially planting of wetland areas to intercept nutrient rich runoff is suggested.

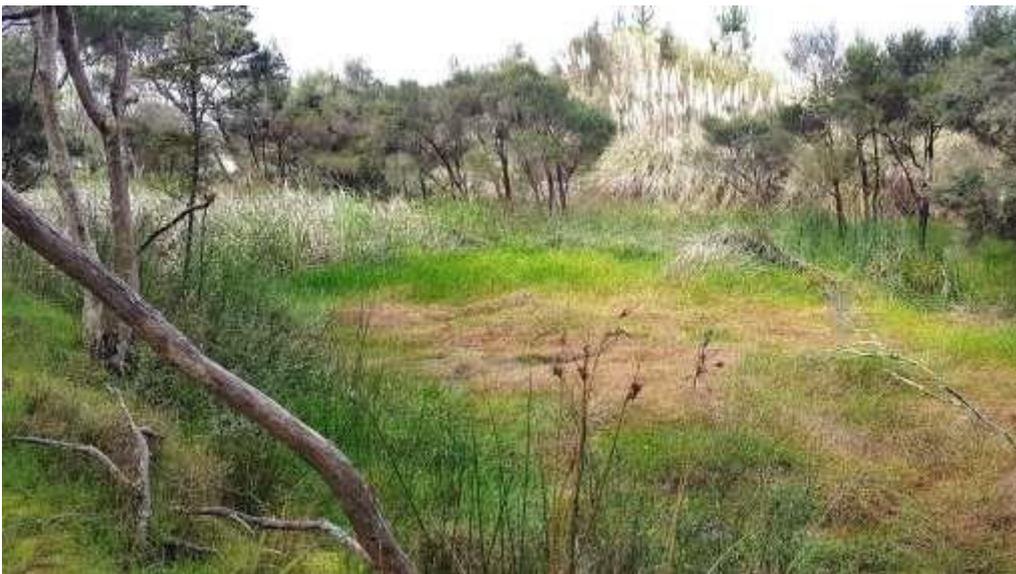
Fenced inflow into Rotopouua. (Photo: Paul Champion 21 September 2018).
