# Ambient PM<sub>10</sub> monitoring adjacent to four unsealed roads in Northland

(Wright, Opouteke, Ngapipito and Piplwai Roads – March/April 2013)

### **E-BAM PM<sub>10</sub> Ambient Air Monitoring Report for Northland Regional Council**

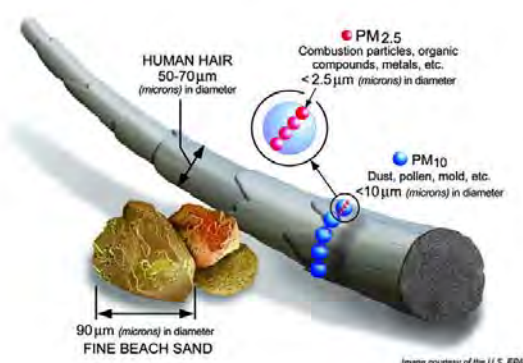
**Figure 1 Particulate matter 10µm size (USEPA)**

Particulate matter is a collective term used to describe very small solid or liquid particles such as dust, fume, smoke and mist or fog. Particulate material, which has an aerodynamic diameter of less than 10 microns (µm), is referred to as “PM<sub>10</sub>” (see Figure 1). PM<sub>10</sub> in the atmosphere originates from both natural, e.g. wind blown dust, forest fires, and anthropogenic activities, e.g. automobile exhausts, solid fuel burning.

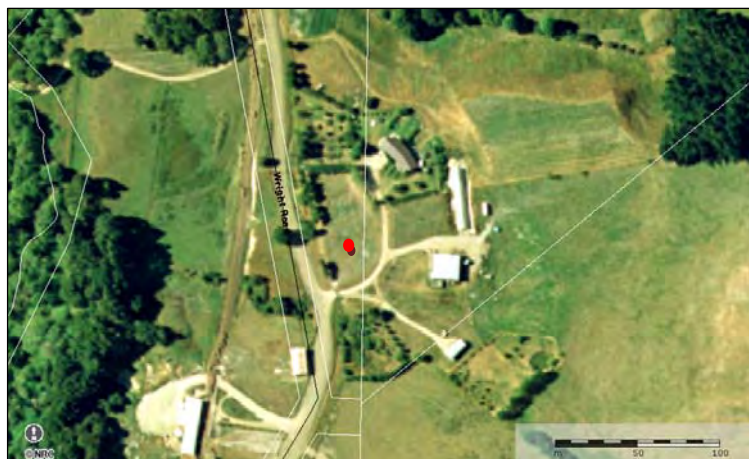
**Photo 1: Location of E-BAM at Wright Road site (NZTM: 1694305E 6053381N)**

The PM<sub>10</sub> monitor was positioned 44 metres away from edge of the road at 634 Wright Road. This monitor was set up on 14 March and monitoring began at 1110 hours and finished at 0910 hours (New Zealand Standard Time) on 22 March 2013. It is important to note that during this period a dust suppressant (“Dust-Lock”) was applied onto the road on 16 March to reduce dust levels. The 24 hour average PM<sub>10</sub> concentrations for the site were well within National Environmental Standards (NES) for air quality (50 µg/m<sup>3</sup>). However, in addition to the effect of the dust suppressant, wind was blowing away from the E-BAM towards the road during the monitoring period which would have decreased the amount of dust measured by the E-BAM. Furthermore, eight millimetres of rainfall was recorded on 17 March at the NRC Waipao/Poroti rain gauge. The monitoring details for the site are presented in Table 1 below.

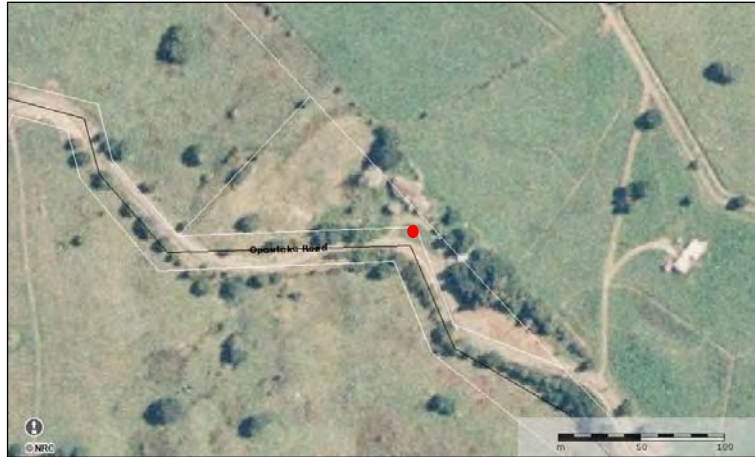
**Photo 2: Location of E-BAM at Opouteke Road site (NZTM: 1677476E 6049096N)**

The E-BAM was located 12 metres from the edge of the road at 442 Opouteke Road. It is noted that the road was treated with dust suppressant in December 2012. There was a power failure at the site between Tuesday 19 March at 1700 hours and 20 March at 1000 hours which reduced the amount of data collected. The highest 24 hour PM<sub>10</sub> average concentration recorded was 321 µg/m<sup>3</sup> on 22 March 2013. All daily PM<sub>10</sub> concentration averages at this site were above the NES of 50 µg/m<sup>3</sup>. The location of the E-BAM was close to the road and so the wind direction would not have had much effect on PM<sub>10</sub> results, and rainfall in the Opouteke area was low during the period monitoring. The monitoring details for the site are presented in Table 2 below.

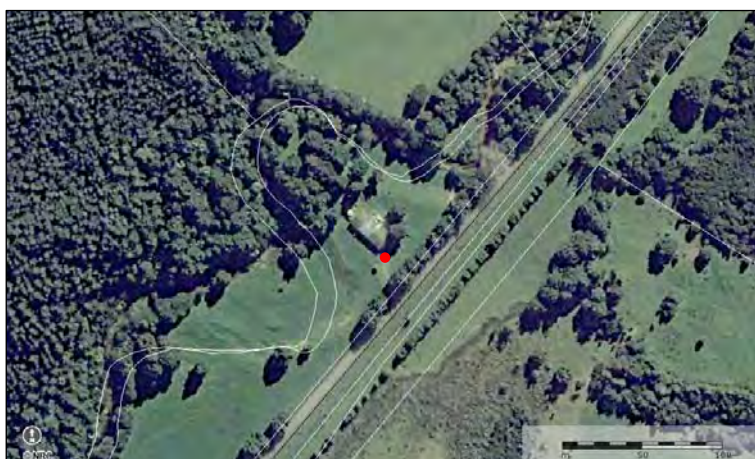
**Photo 3: Location of E-BAM at Ngapipito Road site (NZTM: 1682980E 6079223N)**

The E-BAM was located 27 metres away from the edge of the road at 1120 Ngapipito Road. The daily average PM<sub>10</sub> concentrations exceeded the NES (50 µg/m<sup>3</sup>) on most days during the monitoring period. The highest concentrations were recorded when the wind was ESE, when road dust would have blown in towards the E-BAM. This site also showed the highest deposition gauge dust results among the four unsealed roads monitored in February 2013 (results in Appendix 1). The monitoring details for the site are presented in Table 3 below.

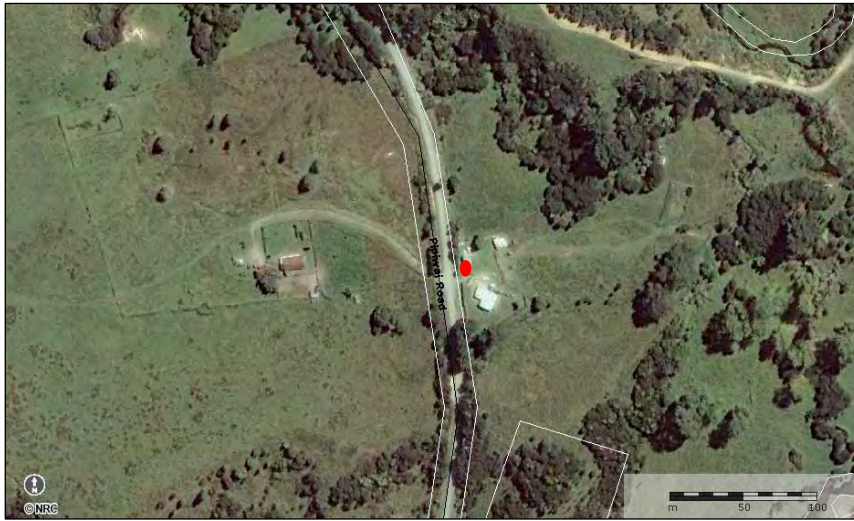
**Photo 4: Location of E-Bam at Pipiwai Road site (NZTM: 1687296E 6063313N)**

The PM<sub>10</sub> monitor was located 14 metres away from the edge of the road at 4116 Pipiwai Road. Monitoring began after a period of rainfall at the end of March and the road in front of the E-BAM had been getting watered to suppress the dust up until 2 April when monitoring began. Monitoring details for the site are presented in Table 4 below.

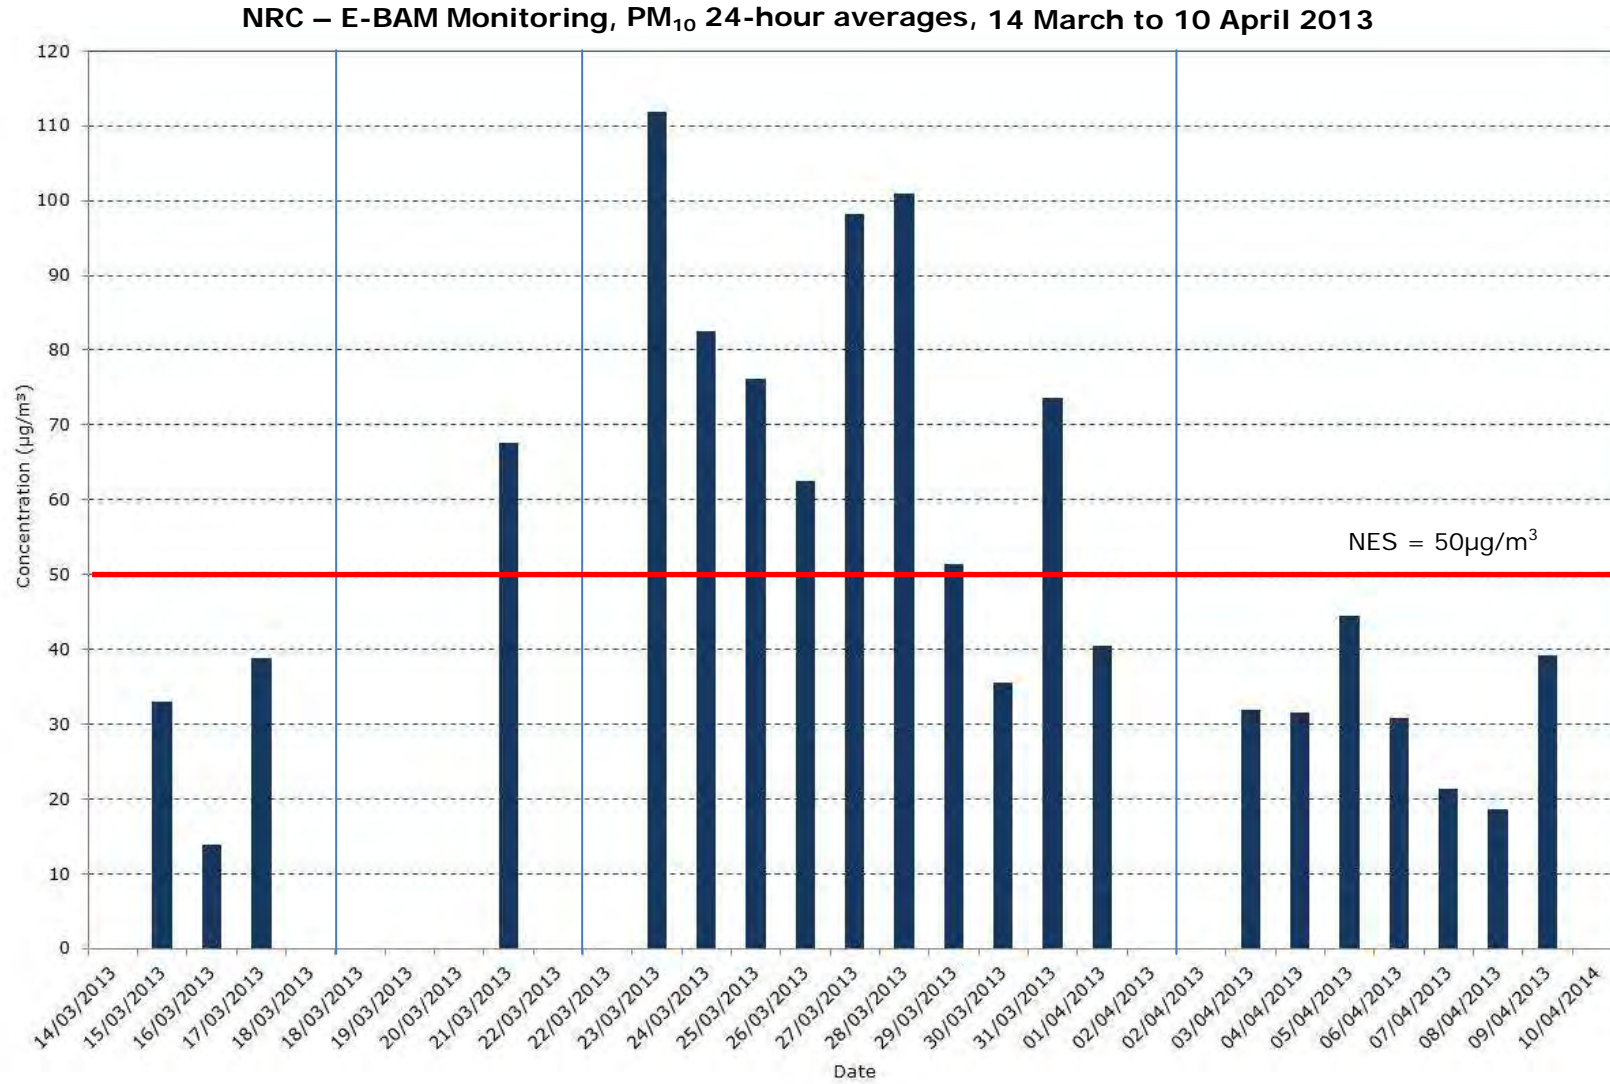
Figure 2: NRC – E-BAM Monitoring (24-hour averages)

Table 3 displays the PM<sub>10</sub> results for the monitoring period from 14 March to 10 April 2013 at the four locations. There were nine valid exceedences of the 50µg/m<sup>3</sup> PM<sub>10</sub> NES (in orange) . Figure 2 graphically displays the 24-hour bar graph during the monitoring period. The *MfE Good Practice Guide for Air Quality Monitoring and Data Management* suggests that it is difficult to reach anything close to 100% valid data for long-term monitoring. For this report, the continuous 10-minute data has been compared against a target of 95%.
